## VISUAL APPRAISAL SURVEY

CHYMBLA HOUSE AND WINKLOW HOUSE,  
FORMER REDRUTH BREWERY SITE,  
REDRUTH,  
CORNWALL, UK

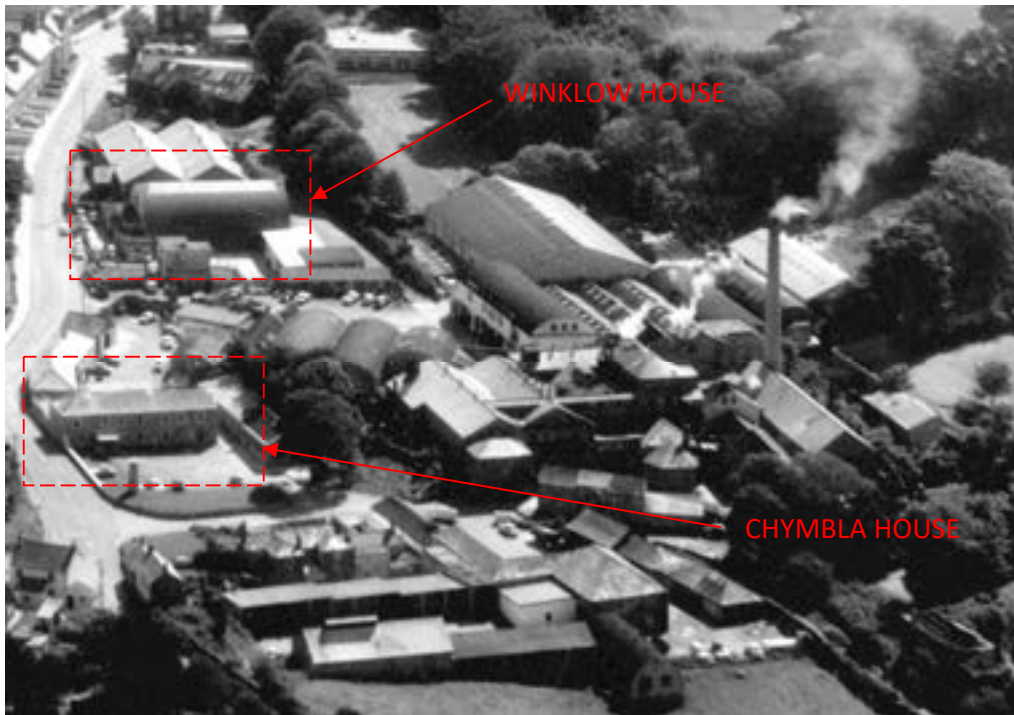
Figure 1 – Historic view of Redruth Brewery Site taken in the 1960s  
(Source: <https://kresenkernow.org/exhibitions/redruth-brewery/>)

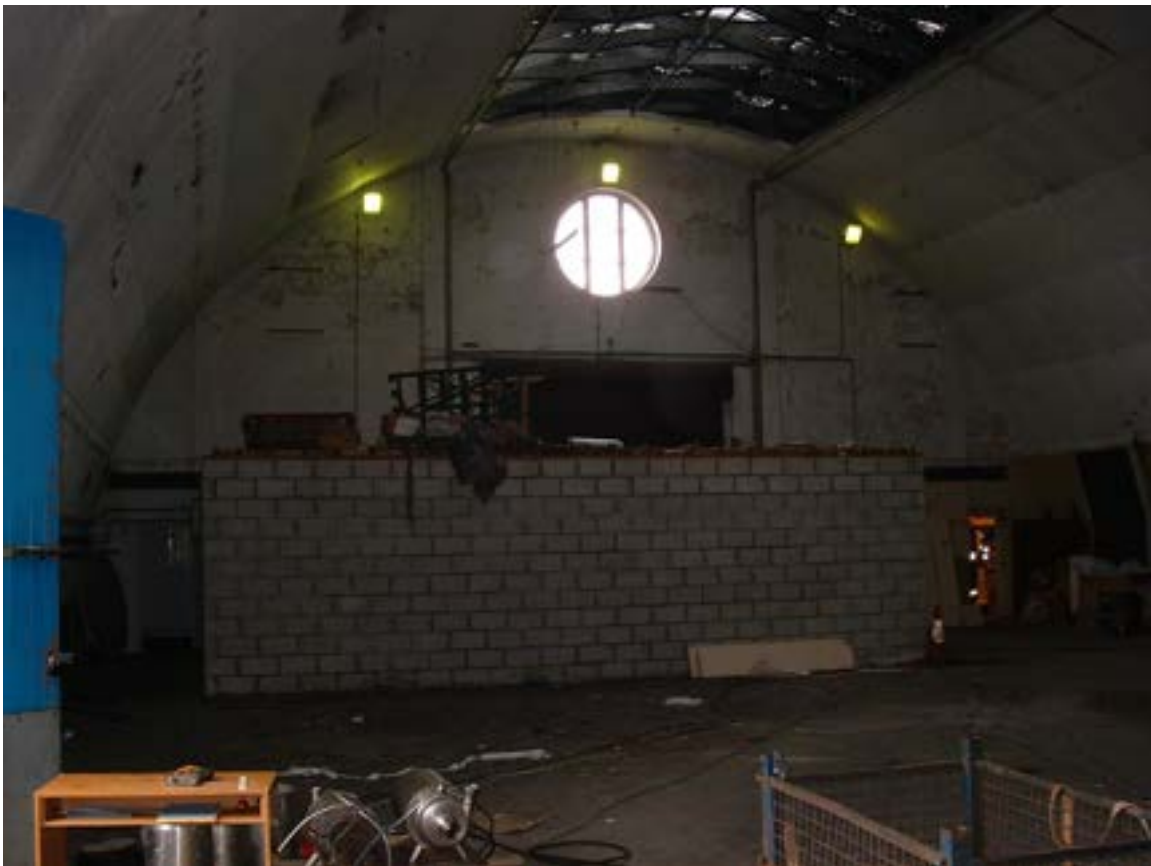
4.4.3 Photo 2 Captioned “Interior – roof construction detail and light well (‘clerestory’)”. The soffit of the Lamella roof structure appears to be boarded to both sides with the exception of the area below the rooflight. The rooflight and circular window both appear to be intact at the time the image was captured. The lamella roof structure is visible and zooming in to the image reveals:

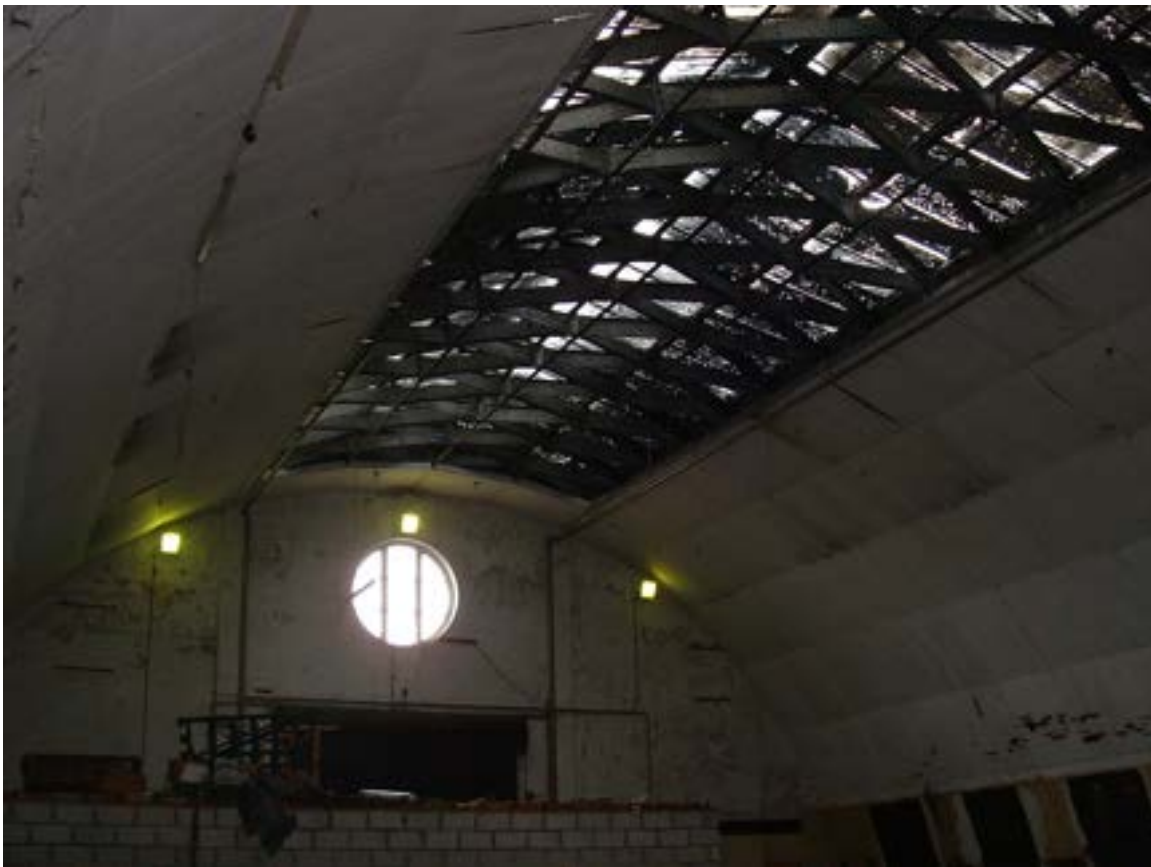
- 4.4.4 Photo 3 Captioned “Internal - tiled floor, visible at side entrance and elsewhere (partially covered by tarmac flooring)”. This shows an area of the floor finish which unfortunately does not provide any information on the construction or condition of the ground floor structure below although the caption insinuates that the floor may have been tarmacked in some areas.

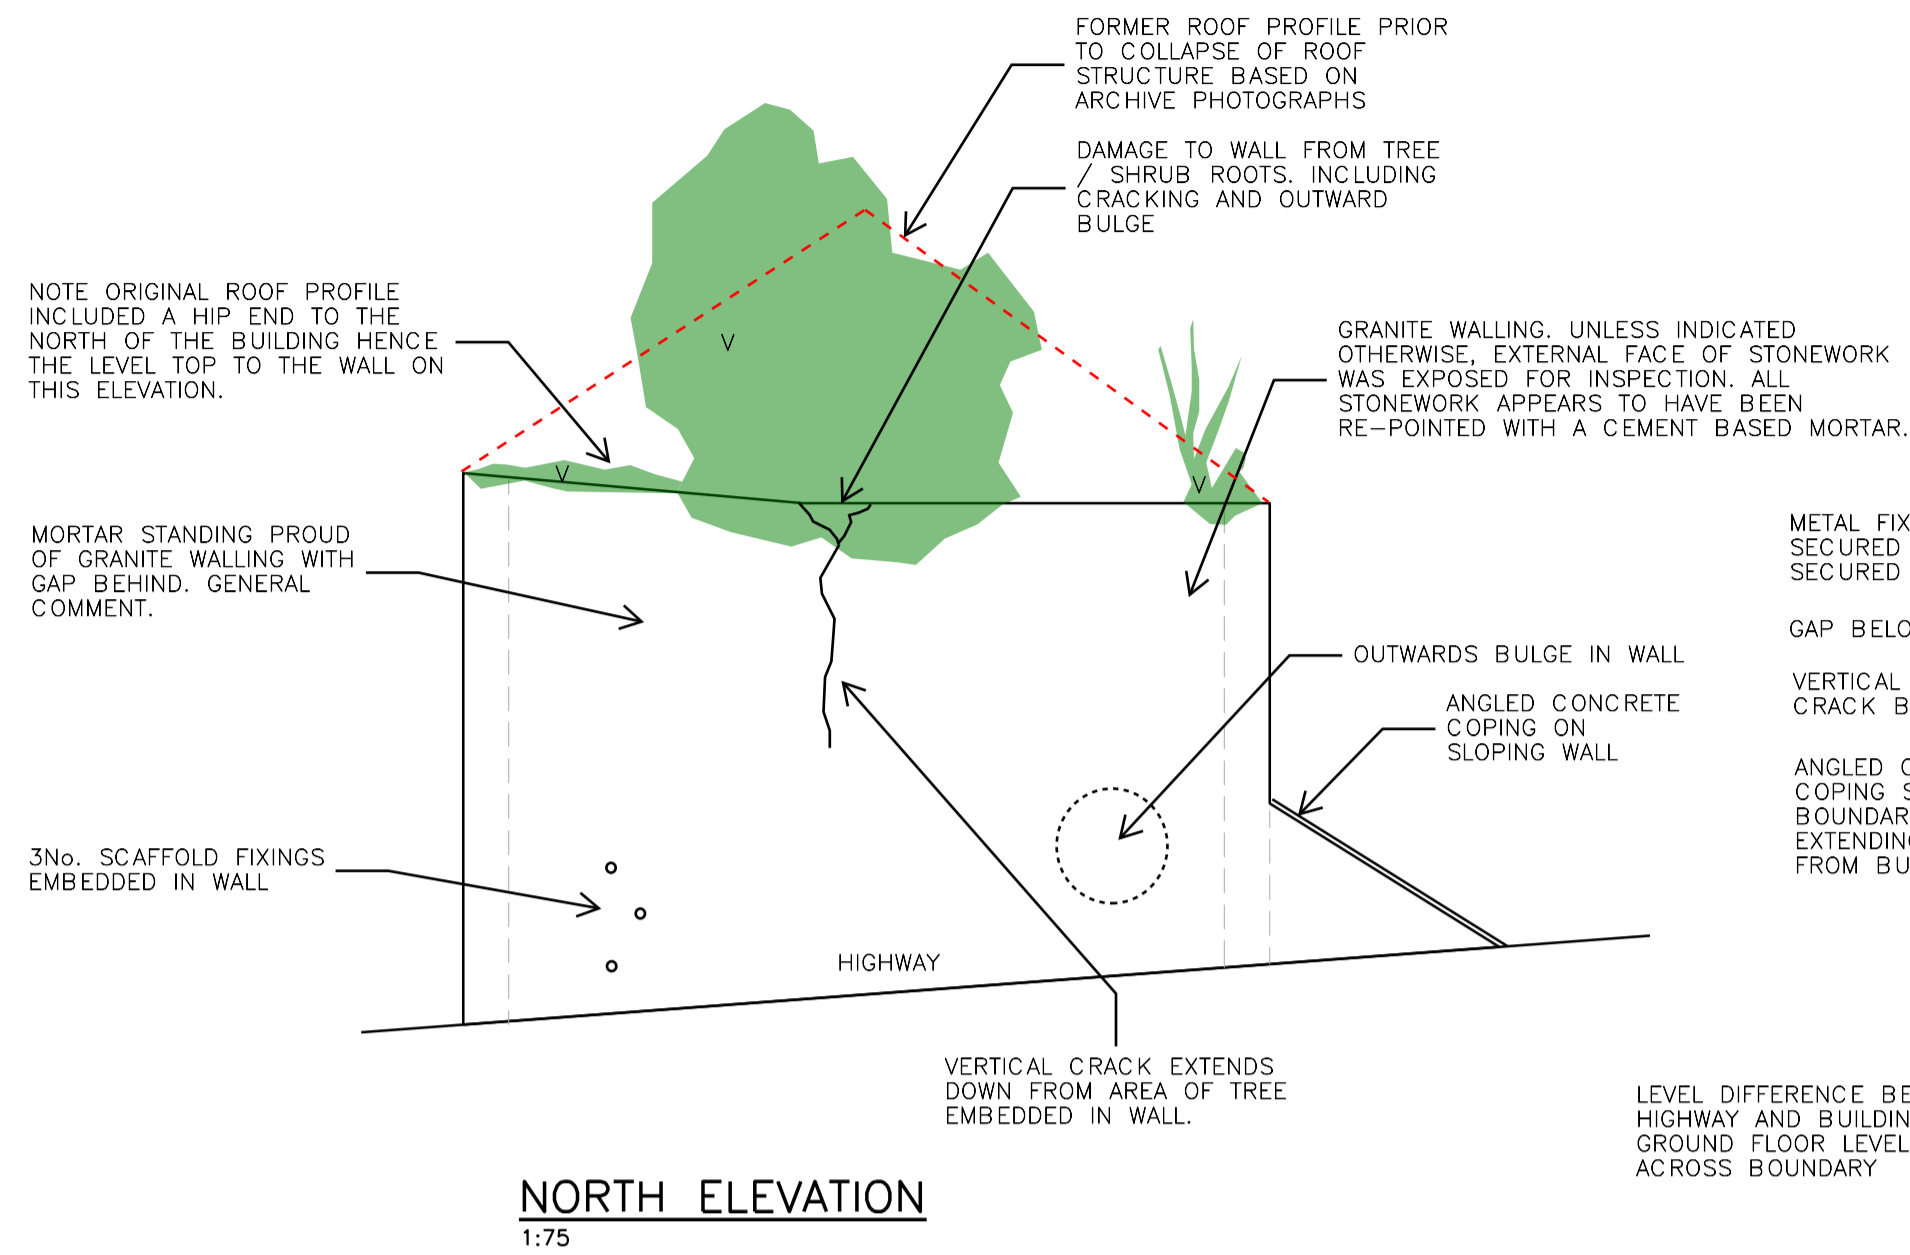
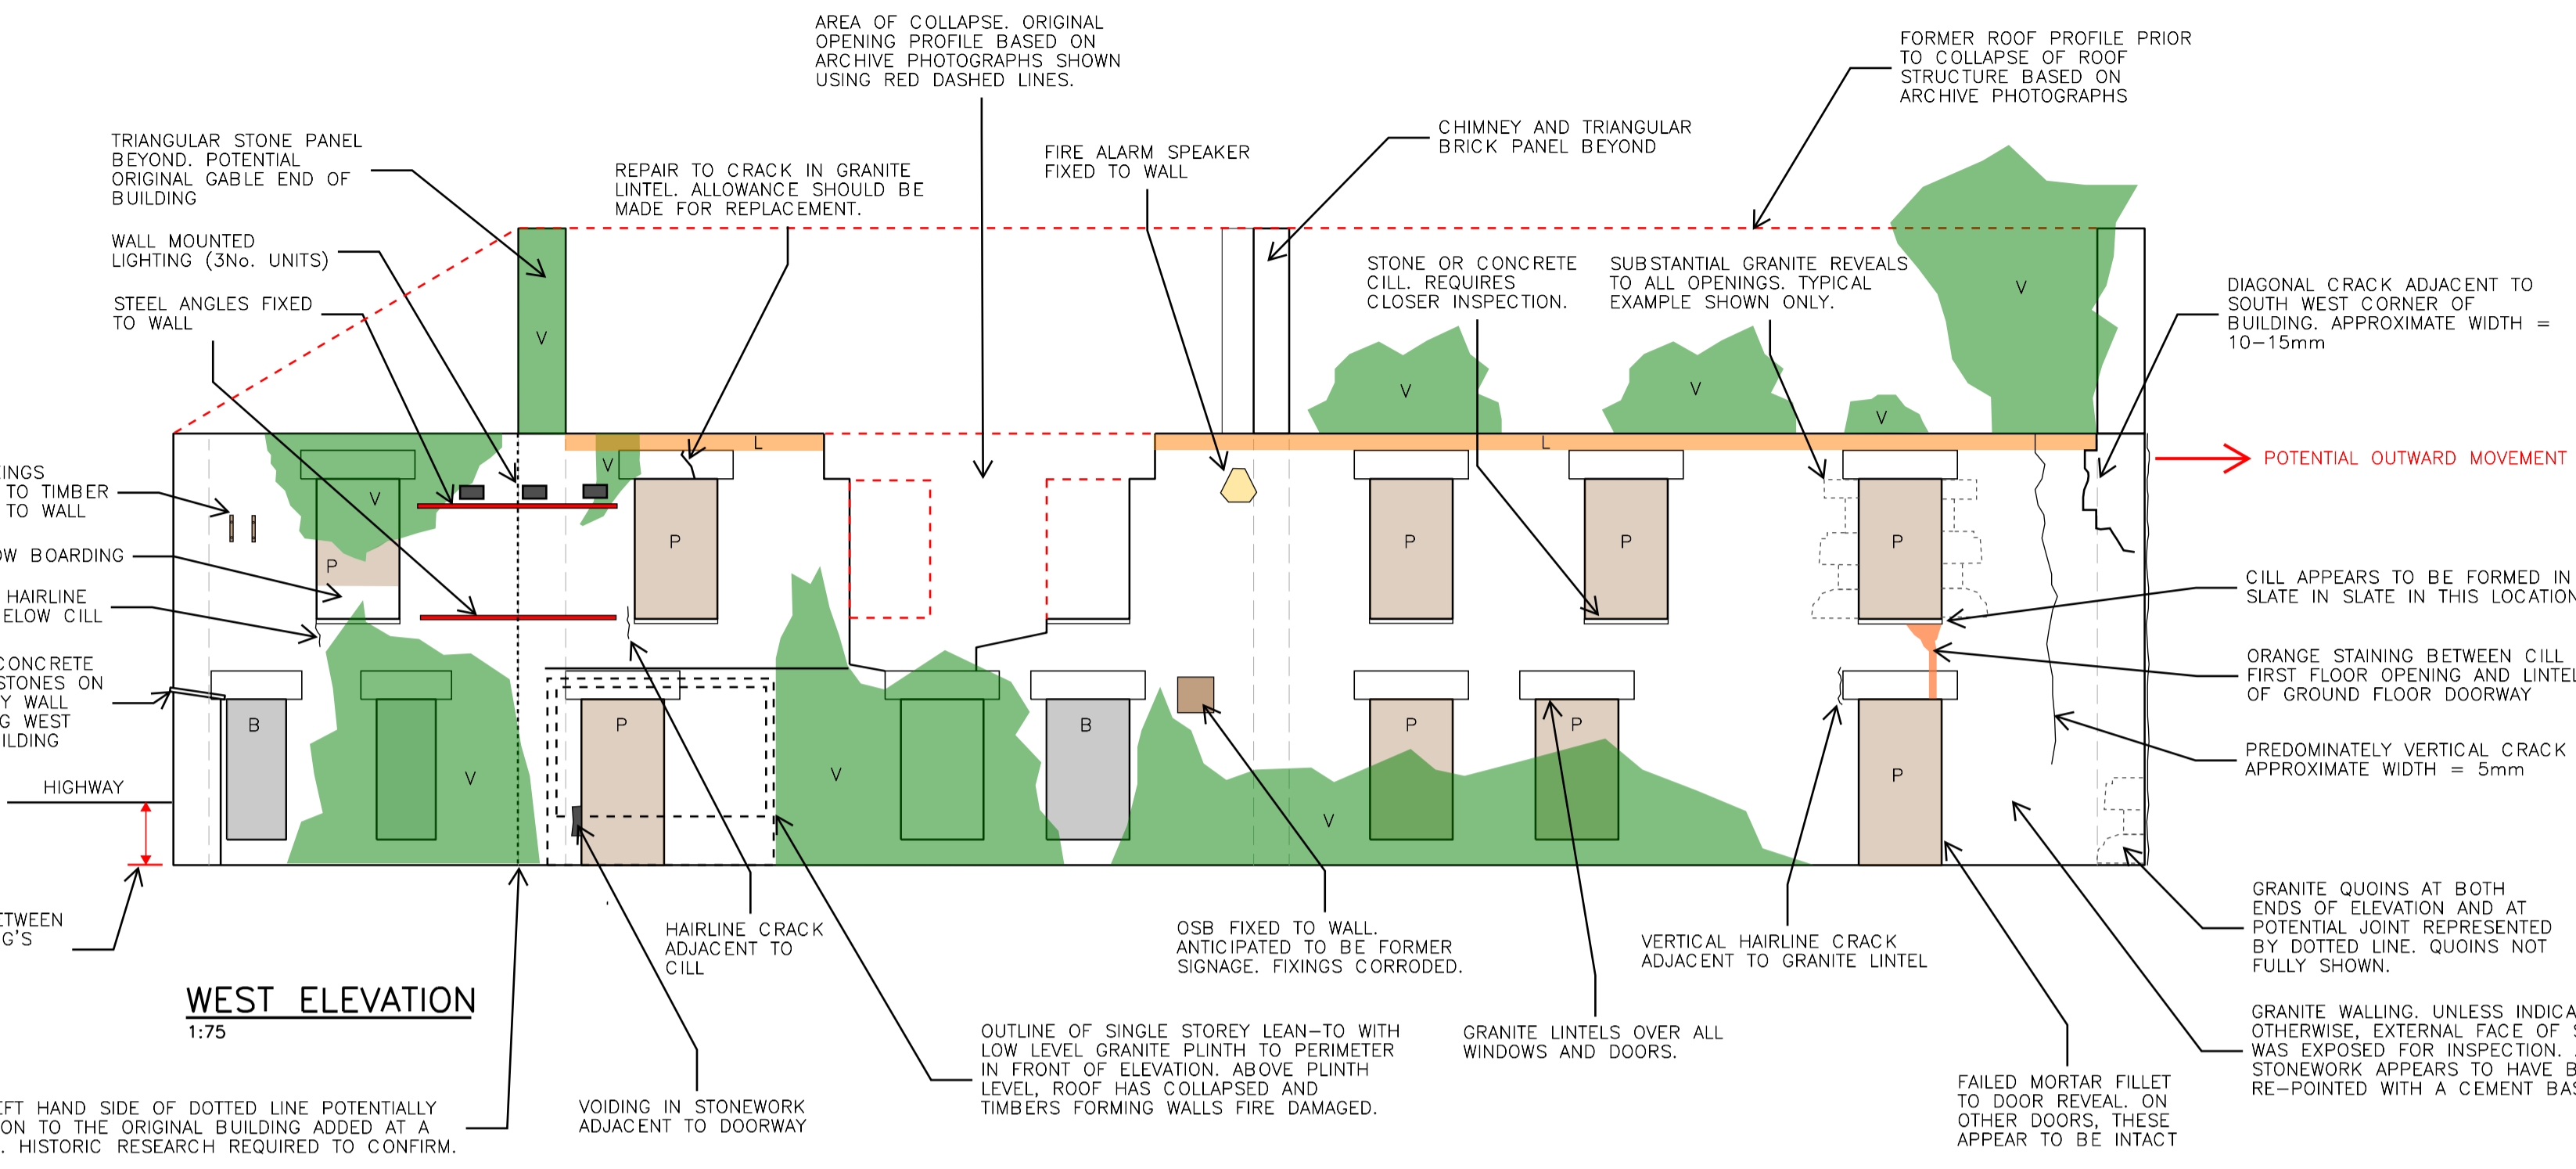
- THIS DRAWING IS NOT TO BE USED FOR CONSTRUCTION UNLESS MARKED ABOVE "FOR CONSTRUCTION"
- THE COPYRIGHT ON THIS DRAWING IS RETAINED BY MICHAEL BEARDSALL ASSOCIATES LTD
- THIS DRAWING IS TO BE READ IN CONJUNCTION WITH ALL RELEVANT ARCHITECTS AND ENGINEERS DRAWINGS AND SPECIFICATIONS
- THE CONTRACTOR IS RESPONSIBLE FOR ALL DIMENSIONS AND THE CORRECT SETTING OUT ON SITE. ONLY FIGURED DIMENSIONS ARE TO BE USED. DO NOT SCALE: IF IN DOUBT ASK. DIMENSIONS SHOULD NOT BE TAKEN ELECTRONICALLY
- ALL MATERIALS AND WORKMANSHIP TO COMPLY WITH THE CURRENT BRITISH STANDARDS AND CODES OF PRACTICE

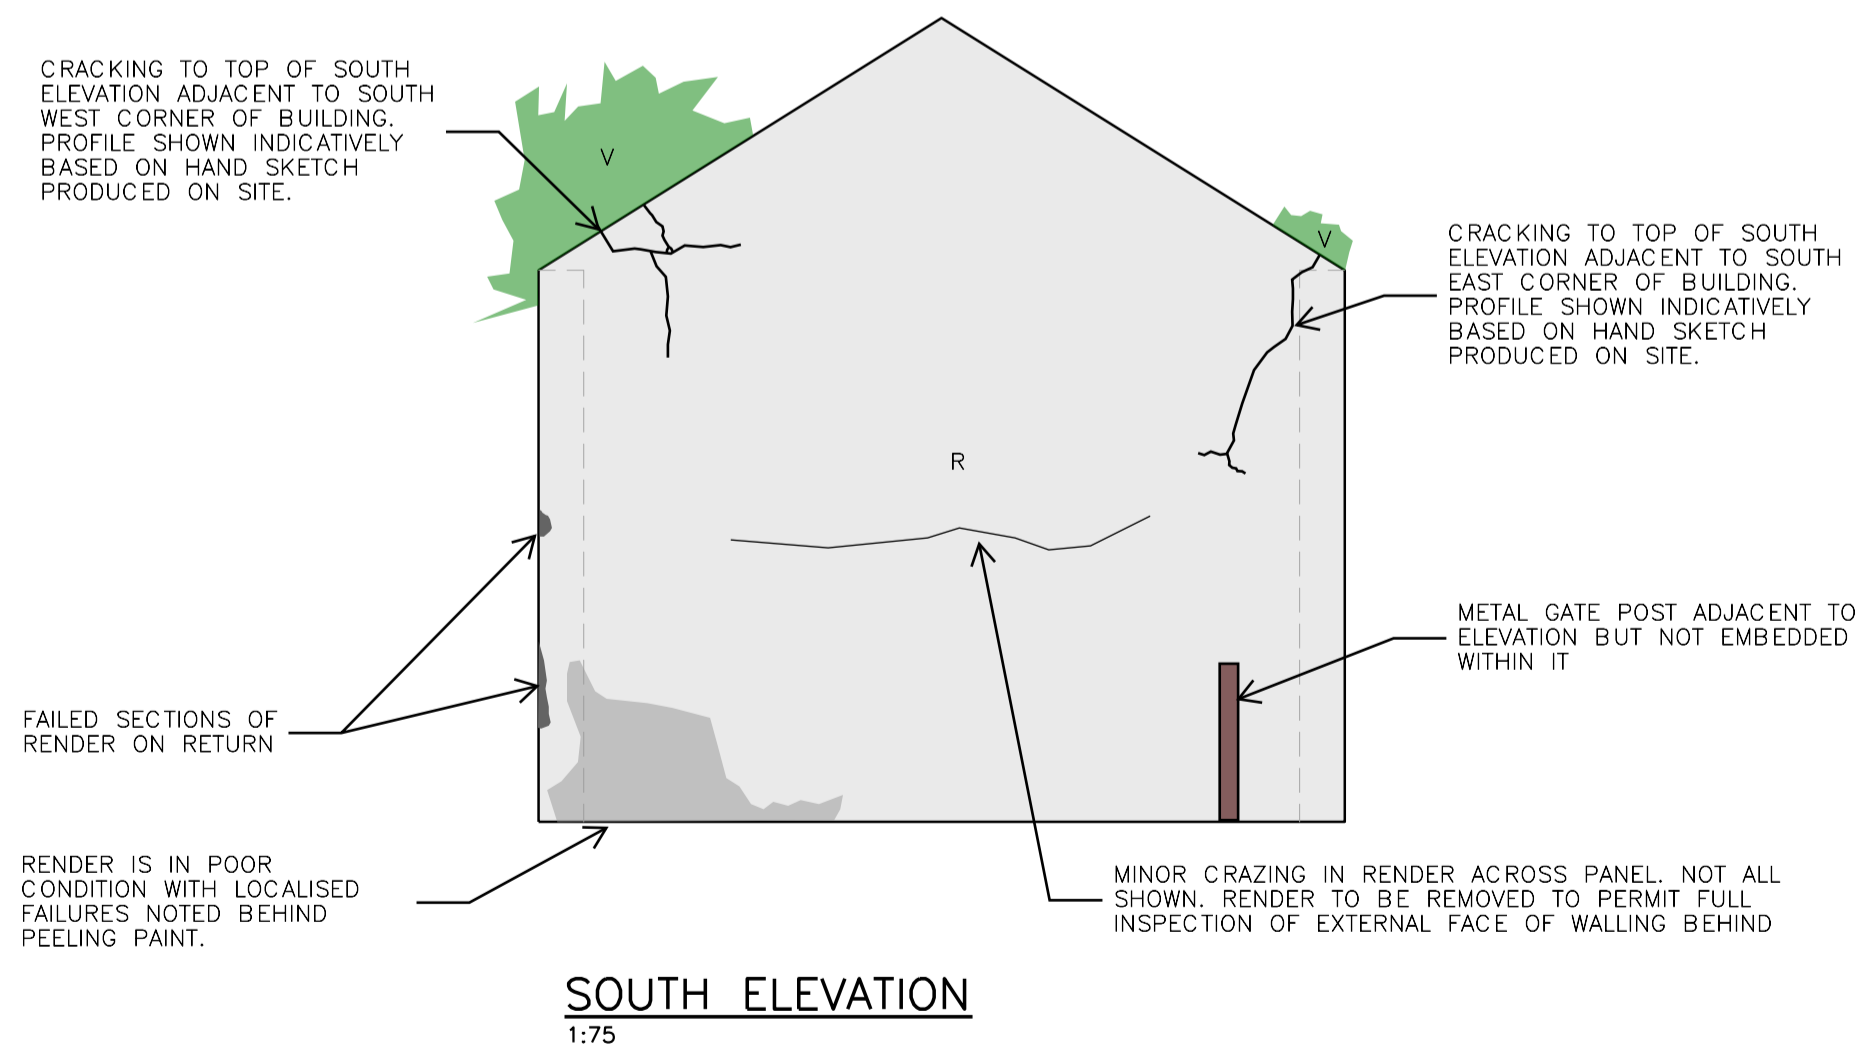
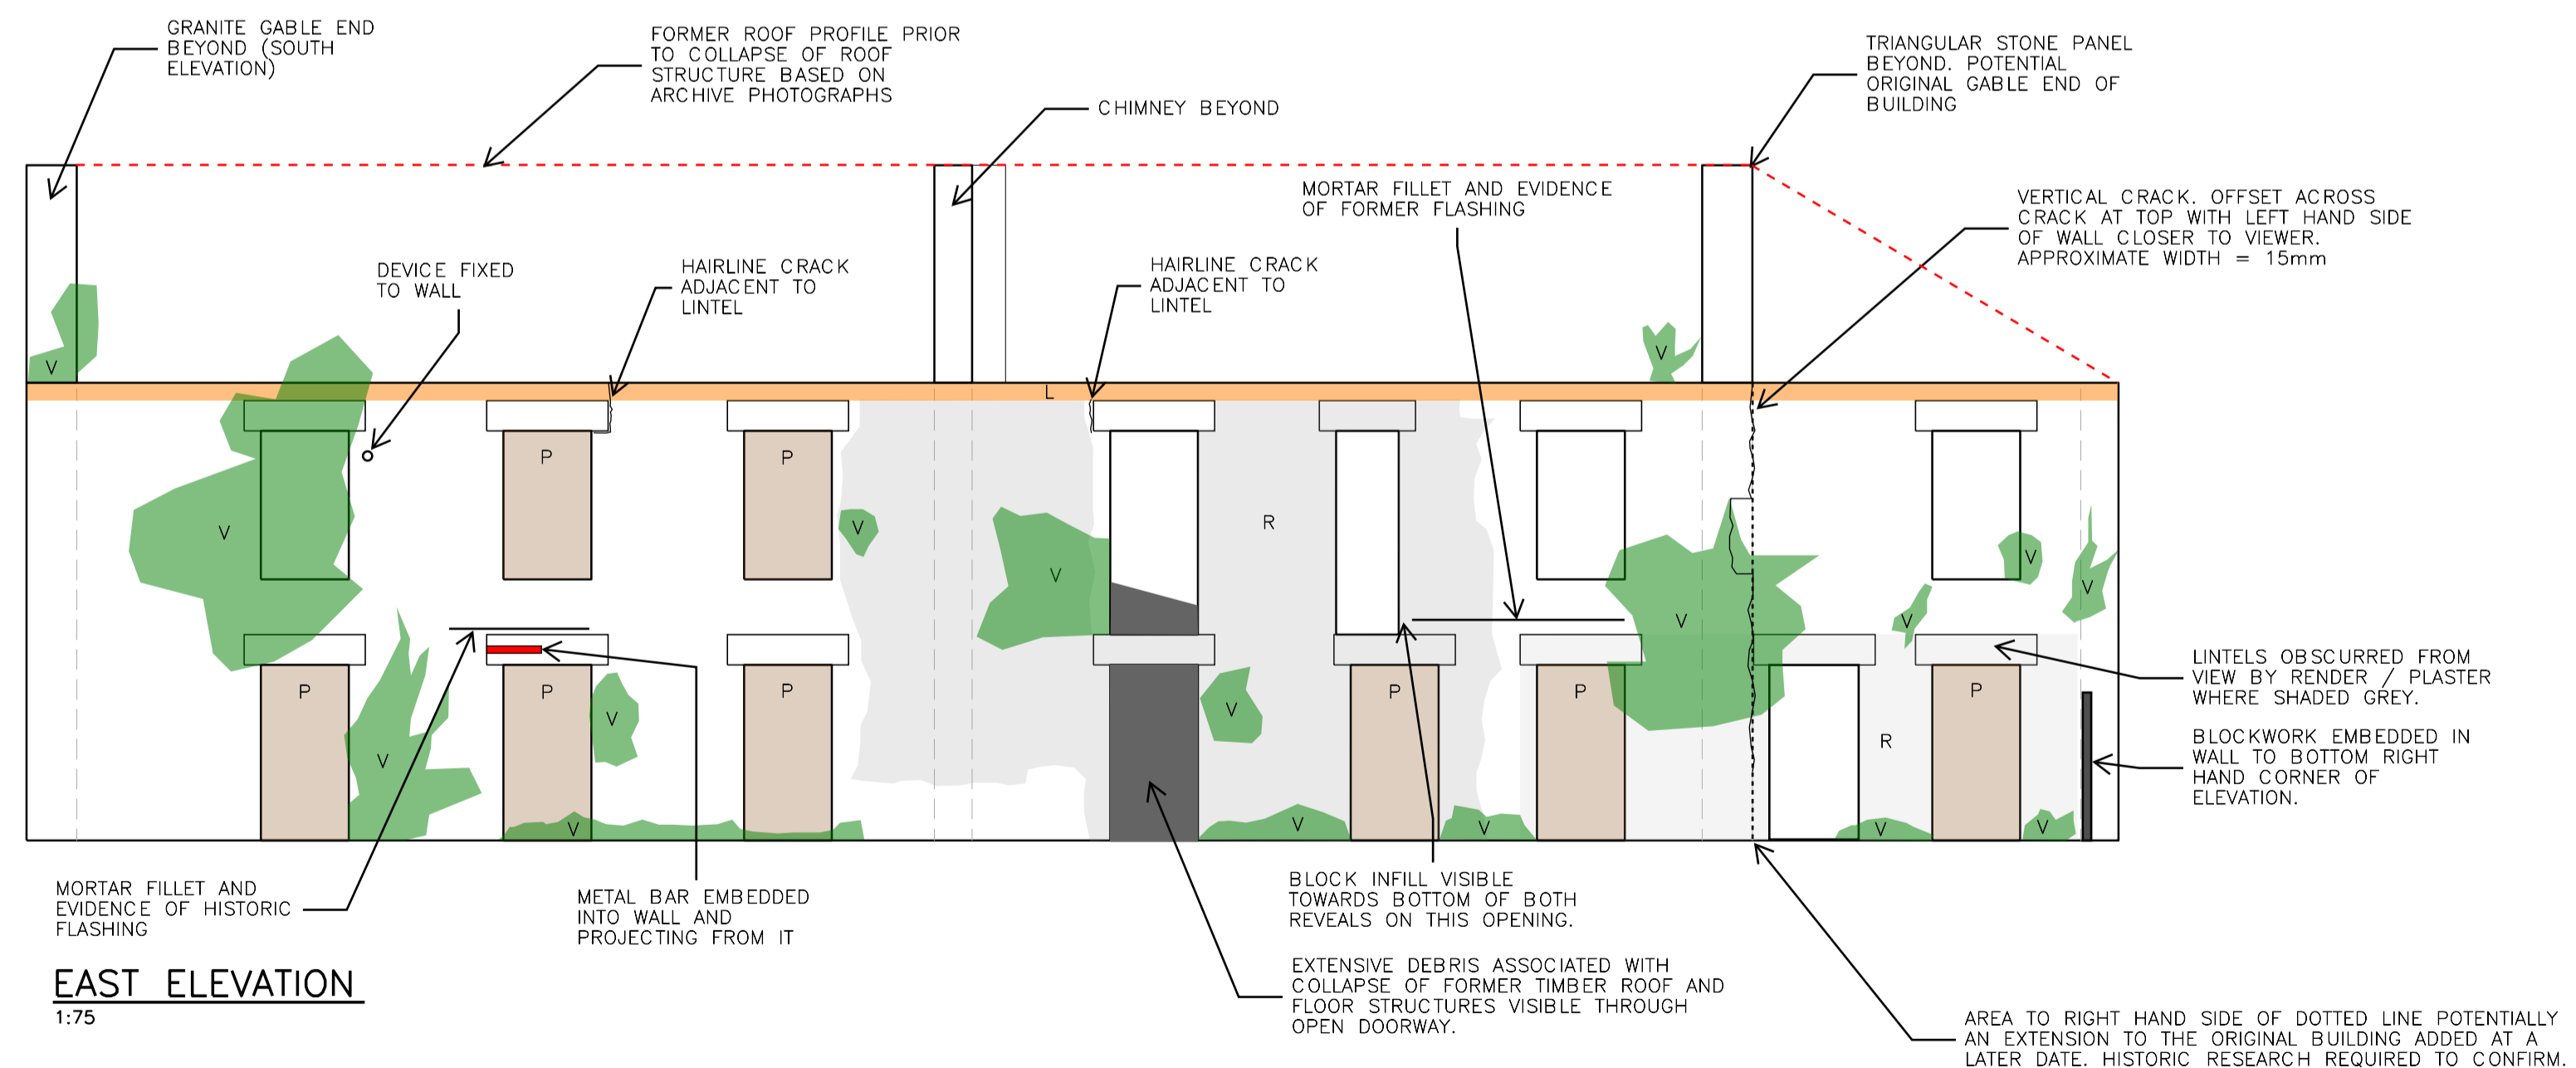
A	04.05.22	REPORT ISSUE	MJH	CCO
	DATE	REVISION SUMMARY	BY	CHK

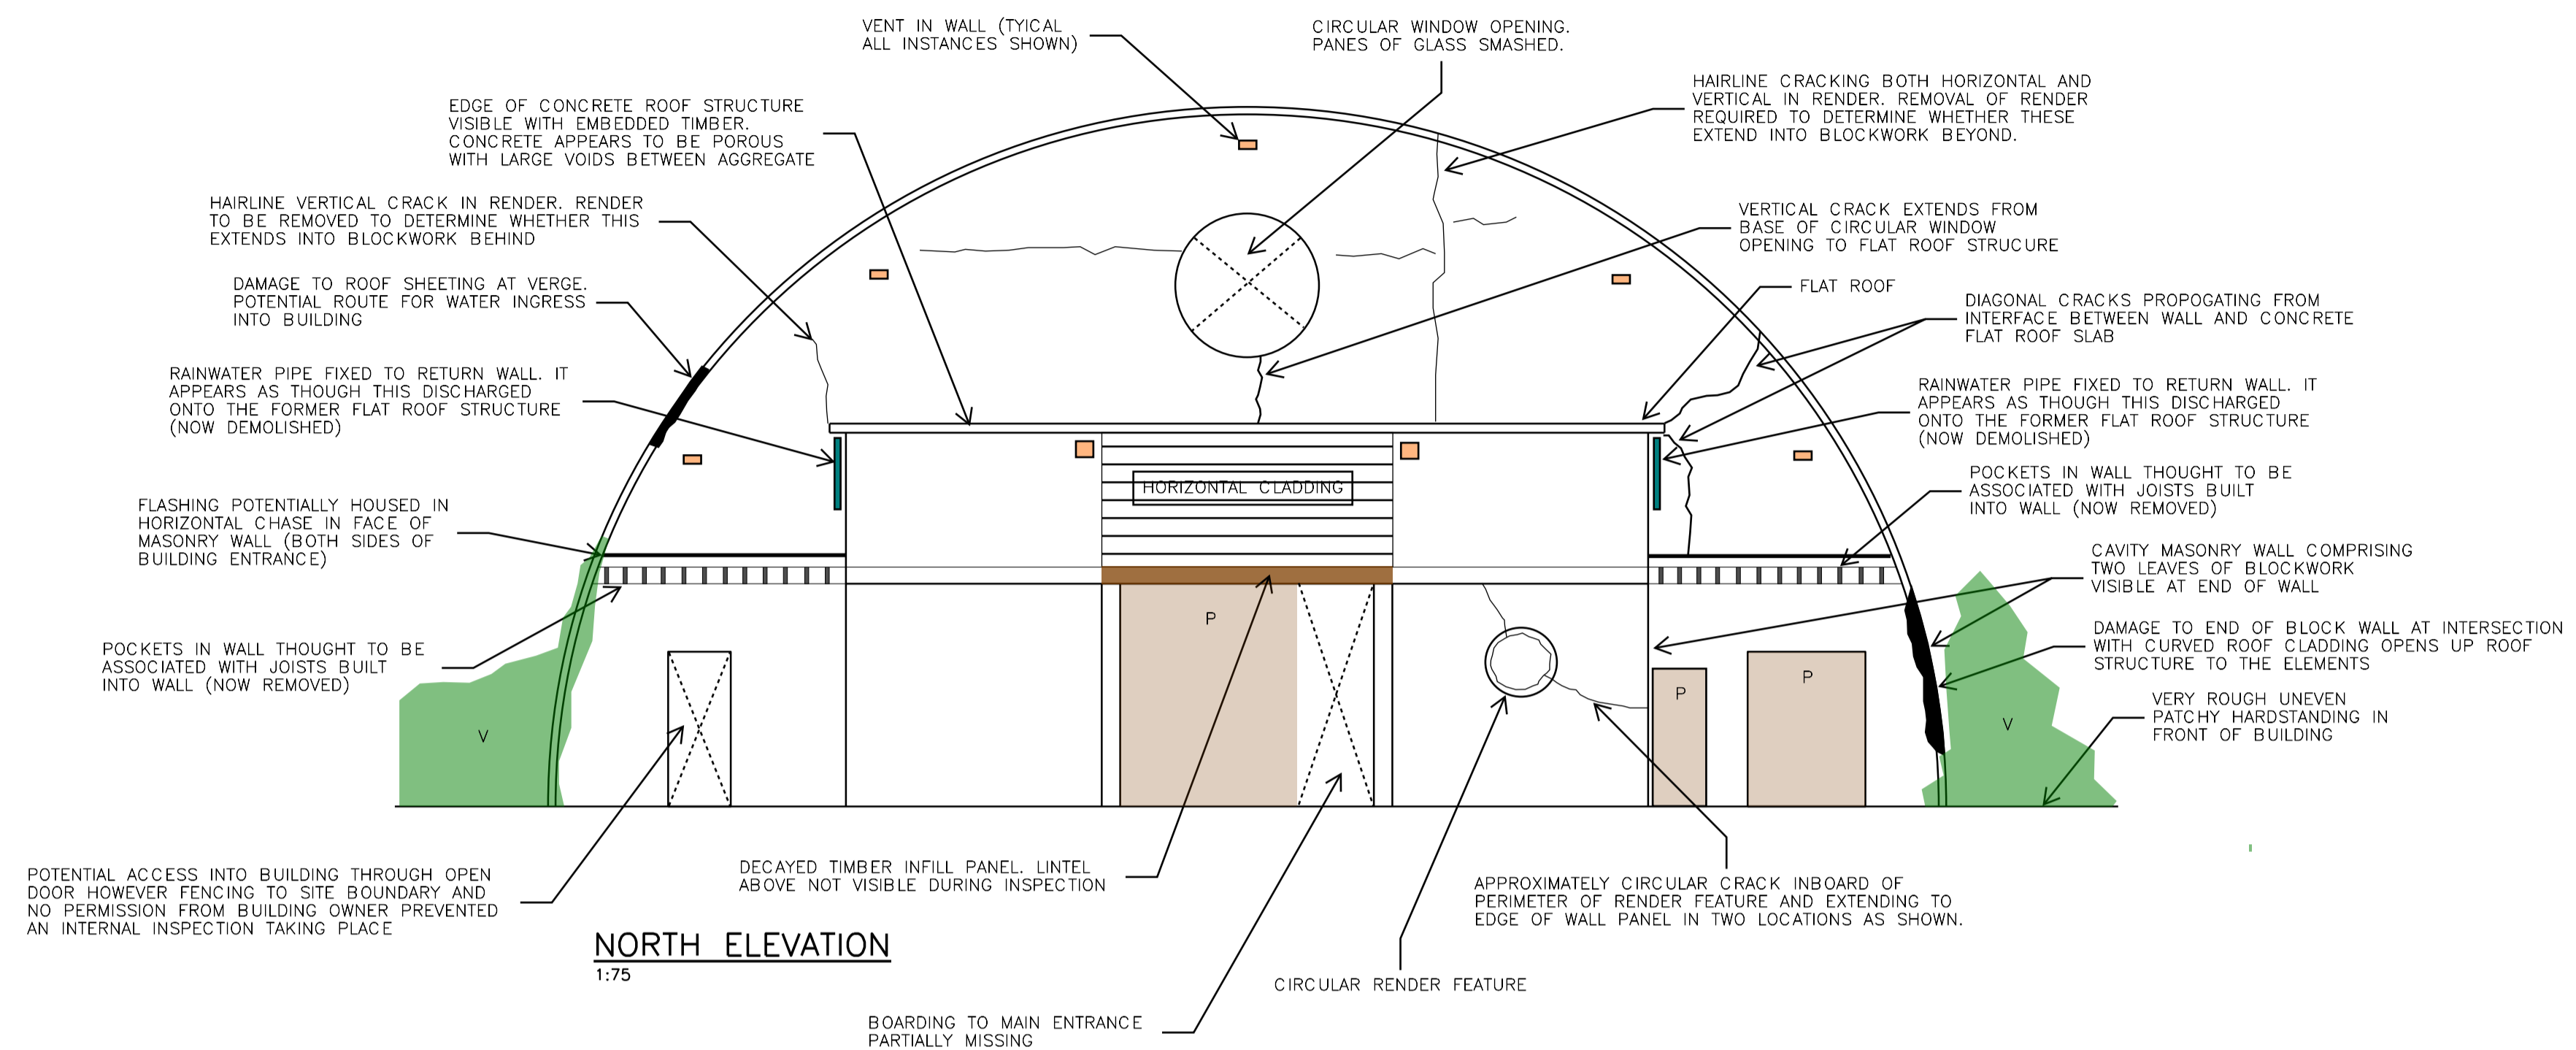
- THIS DRAWING IS NOT TO BE USED FOR CONSTRUCTION UNLESS MARKED ABOVE "FOR CONSTRUCTION"
- THE COPYRIGHT ON THIS DRAWING IS RETAINED BY MICHAEL BEARDSALL ASSOCIATES LTD
- THIS DRAWING IS TO BE READ IN CONJUNCTION WITH ALL RELEVANT ARCHITECTS AND ENGINEERS DRAWINGS AND SPECIFICATIONS
- THE CONTRACTOR IS RESPONSIBLE FOR ALL DIMENSIONS AND THE CORRECT SETTING OUT ON SITE. ONLY FIGURED DIMENSIONS ARE TO BE USED  
**DO NOT SCALE** : IF IN DOUBT ASK DIMENSIONS **SHOULD NOT** BE TAKEN ELECTRONICALLY
- ALL MATERIALS AND WORKMANSHIP TO COMPLY WITH THE CURRENT BRITISH STANDARDS AND CODES OF PRACTICE

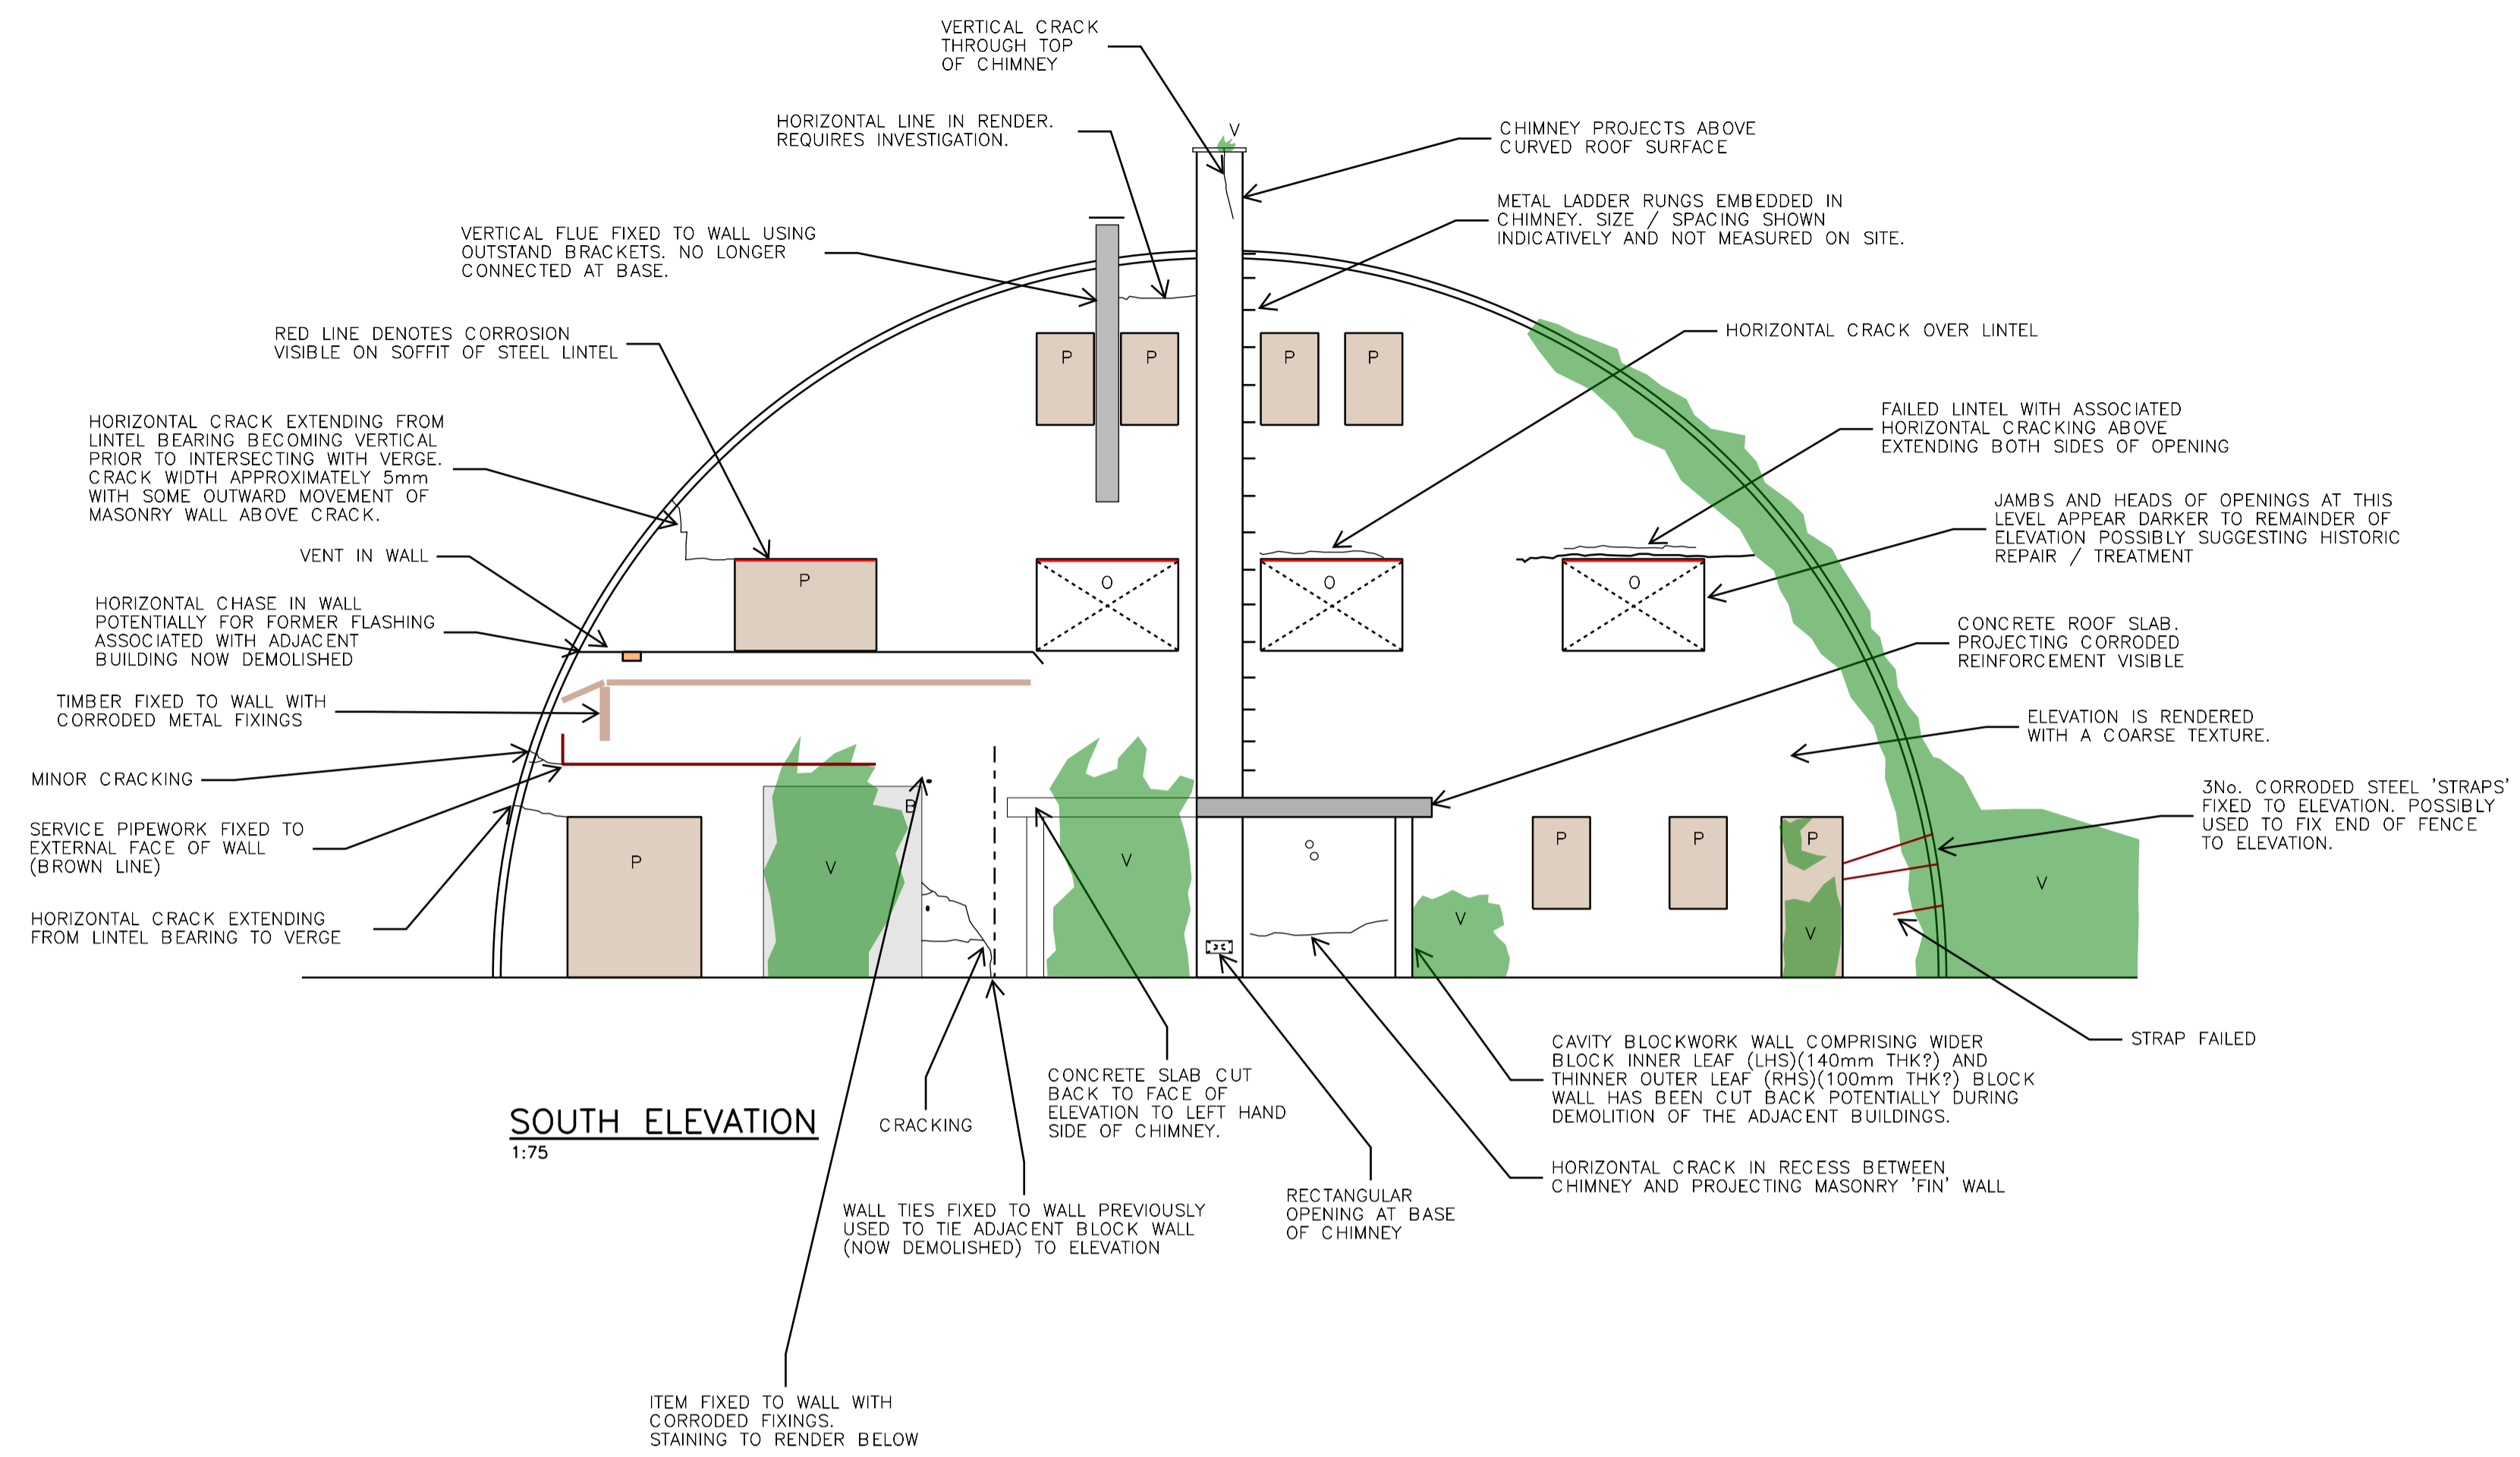
- THIS DRAWING IS NOT TO BE USED FOR CONSTRUCTION UNLESS MARKED ABOVE "FOR CONSTRUCTION"
- THE COPYRIGHT ON THIS DRAWING IS RETAINED BY MICHAEL BEARDSALL ASSOCIATES LTD
- THIS DRAWING IS TO BE READ IN CONJUNCTION WITH ALL RELEVANT ARCHITECTS AND ENGINEERS DRAWINGS AND SPECIFICATIONS
- THE CONTRACTOR IS RESPONSIBLE FOR ALL DIMENSIONS AND THE CORRECT SETTING OUT ON SITE. ONLY FIGURED DIMENSIONS ARE TO BE USED  
DO NOT SCALE : IF IN DOUBT ASK  
DIMENSIONS SHOULD NOT BE TAKEN ELECTRONICALLY
- ALL MATERIALS AND WORKMANSHIP TO COMPLY WITH THE CURRENT BRITISH STANDARDS AND CODES OF PRACTICE

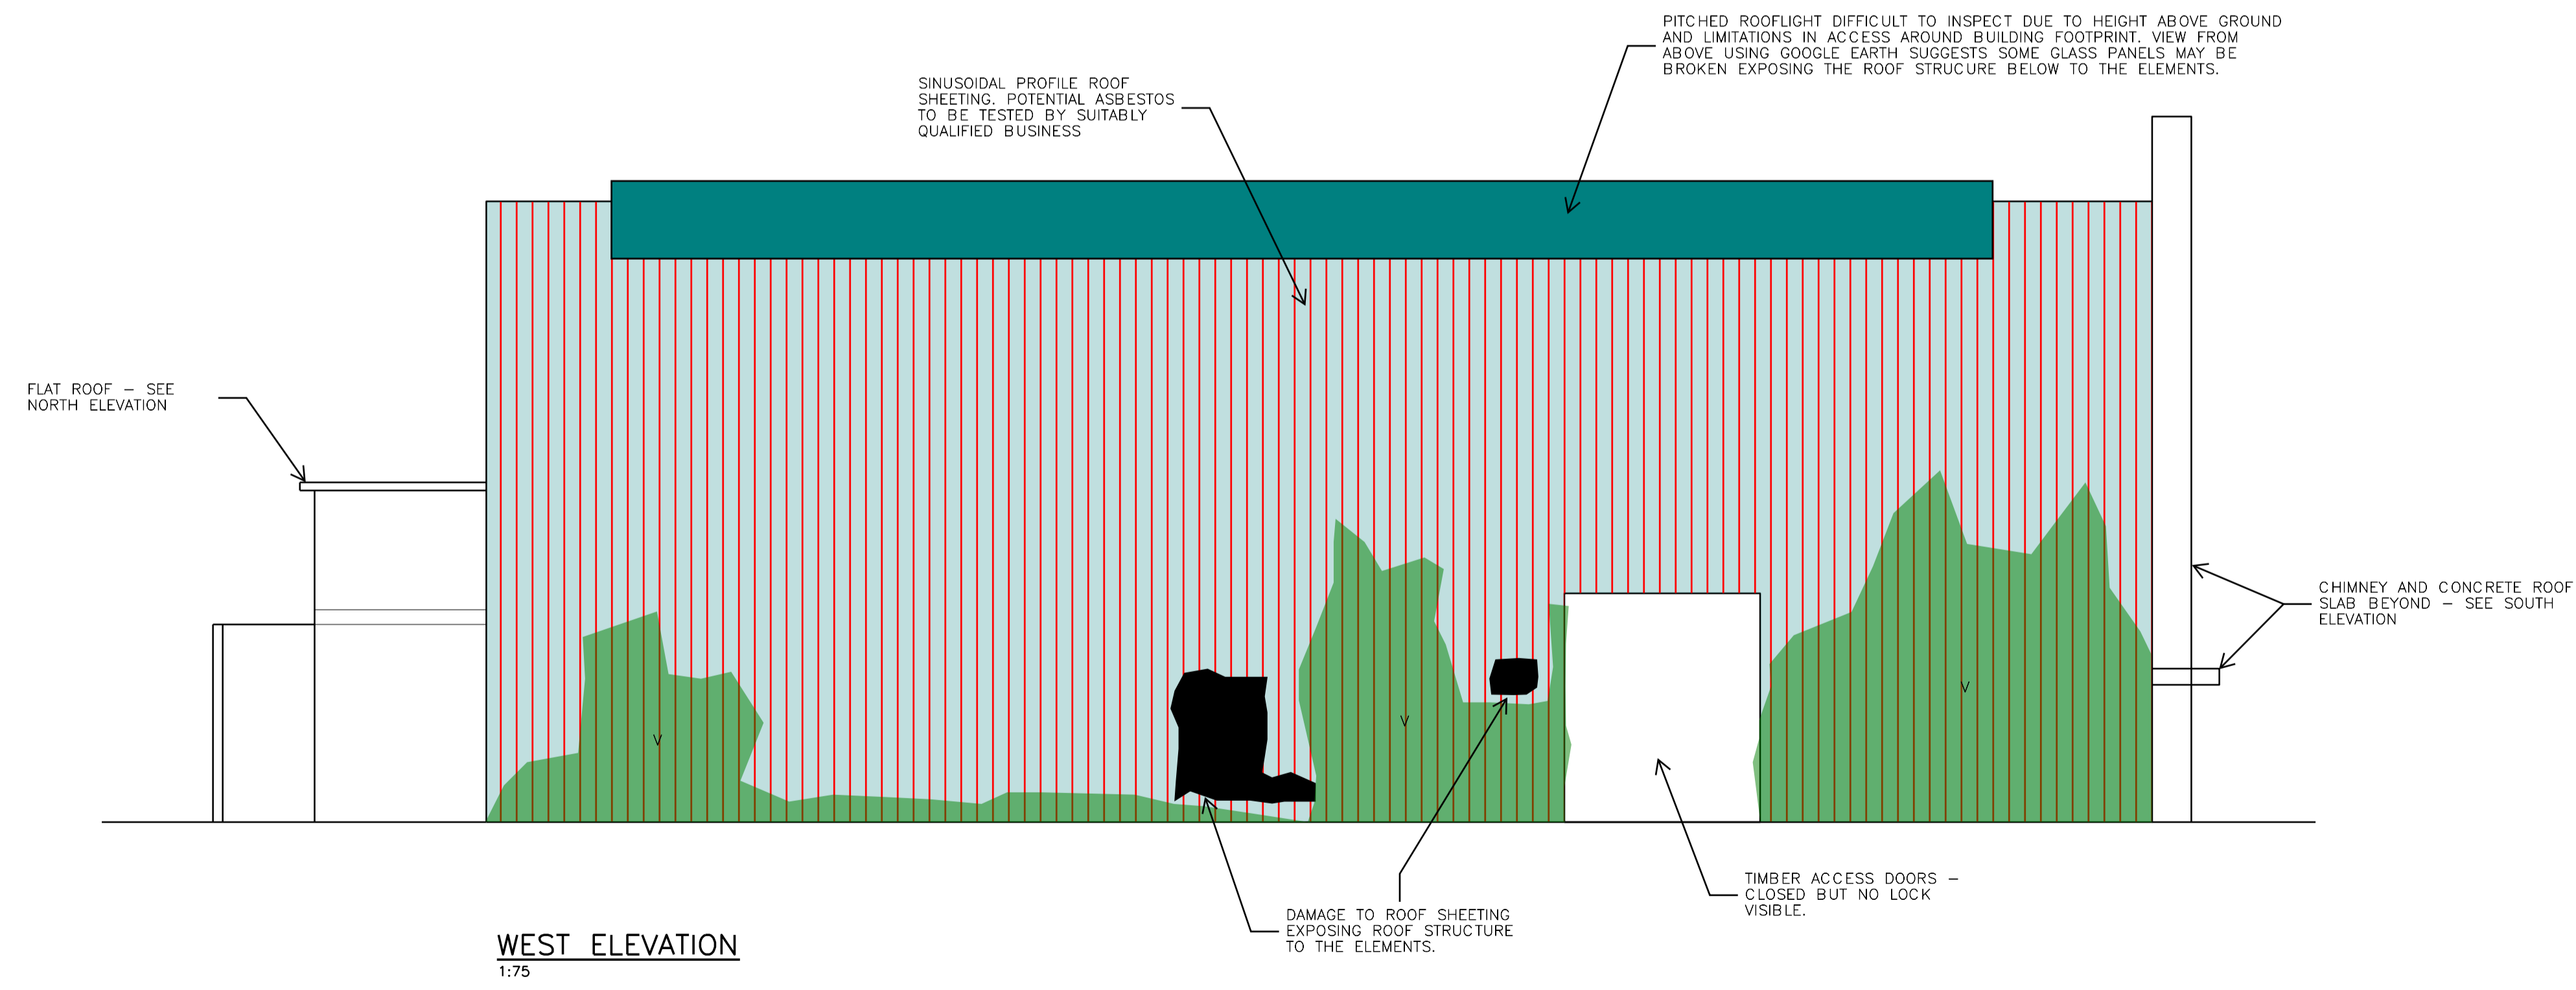
A	04.05.22	REPORT ISSUE	MJH	CCO
	DATE	REVISION SUMMARY	BY	CHK
