## VISUAL APPRAISAL SURVEY

CHYMBLA HOUSE AND WINKLOW HOUSE,  
FORMER REDRUTH BREWERY SITE,  
REDRUTH,  
CORNWALL, UK

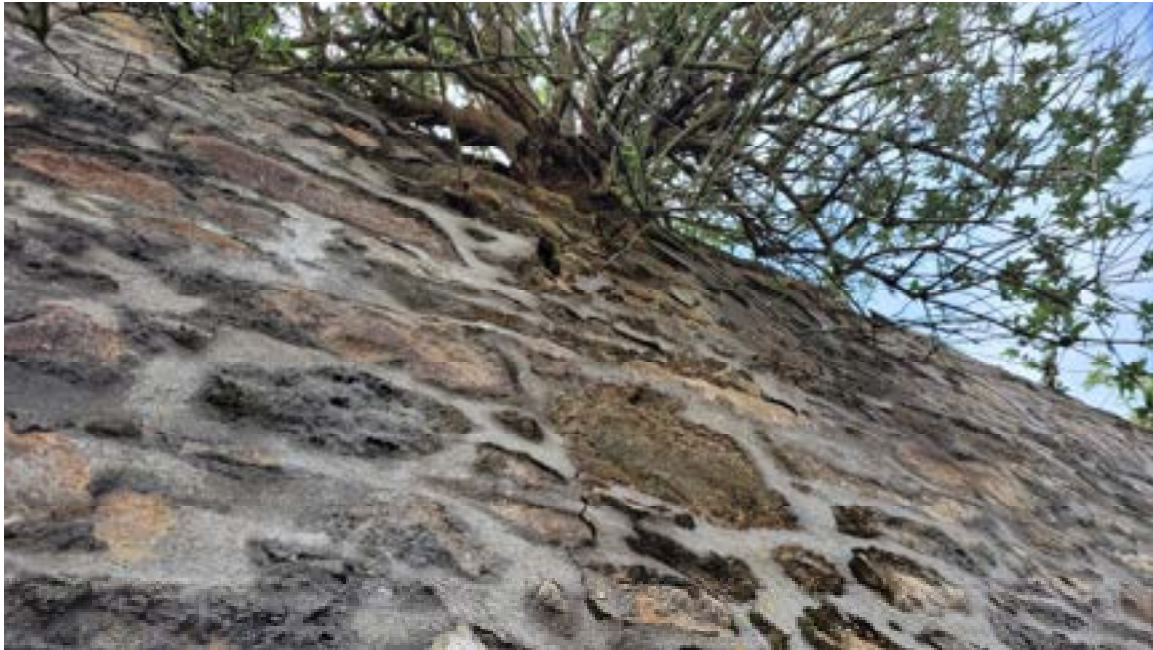
3. Damage to stonework on north elevation.

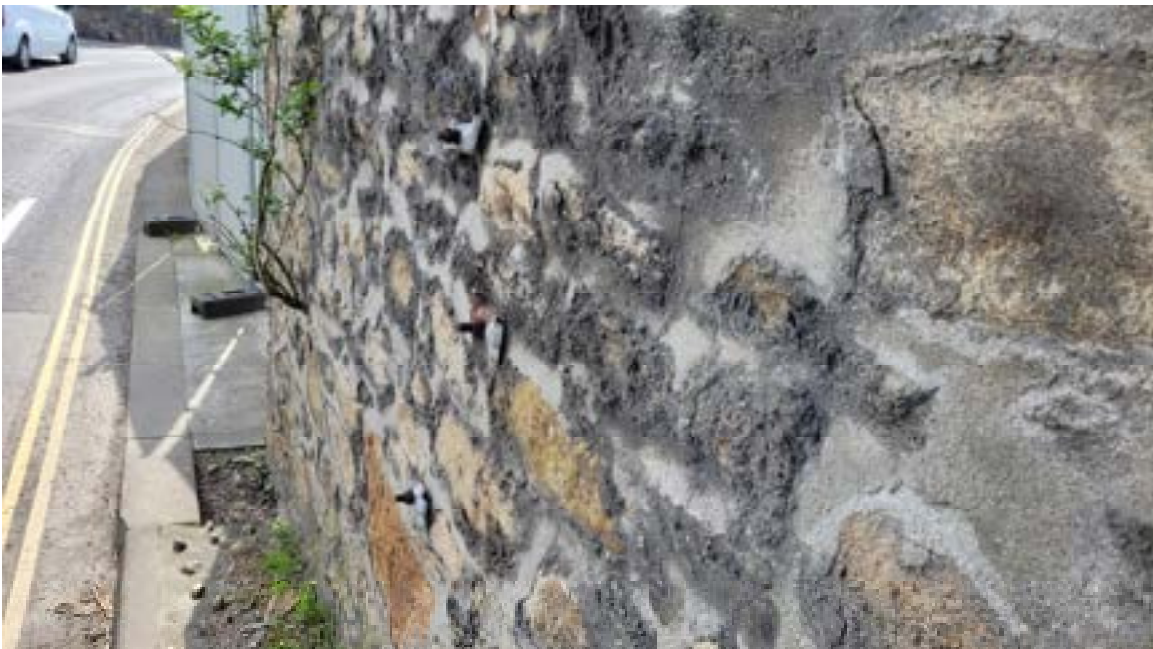
4. Fixings embedded in the north elevation potentially from previous scaffold installation but checks required to ensure these are not securing the stonework.

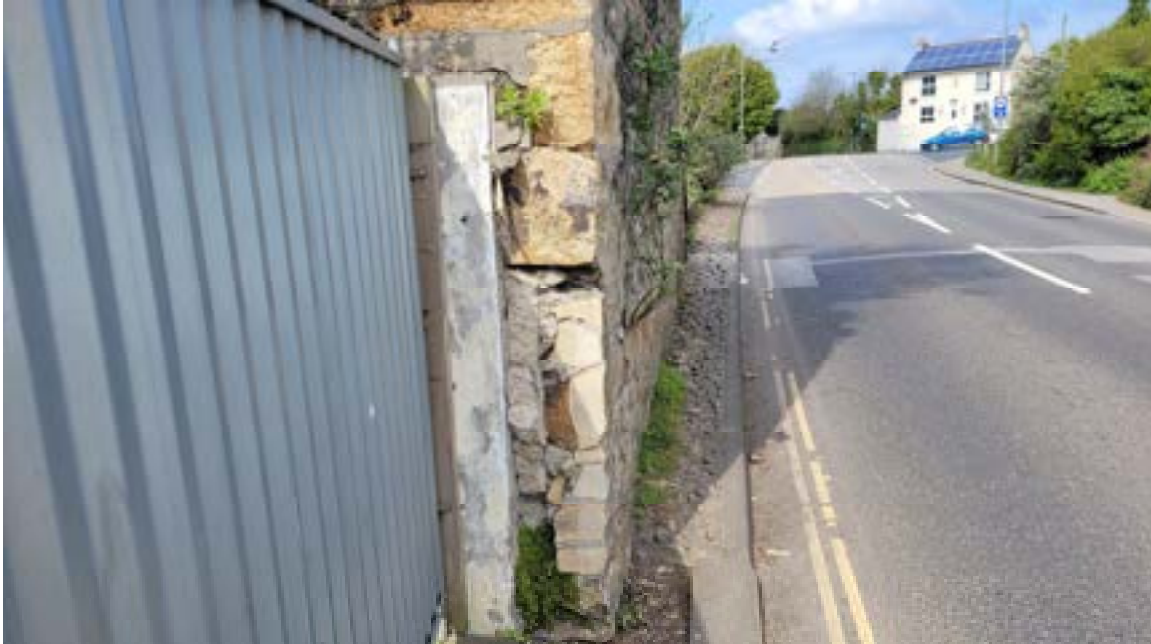
6. North east corner of building. Blockwork infill and loose stonework.

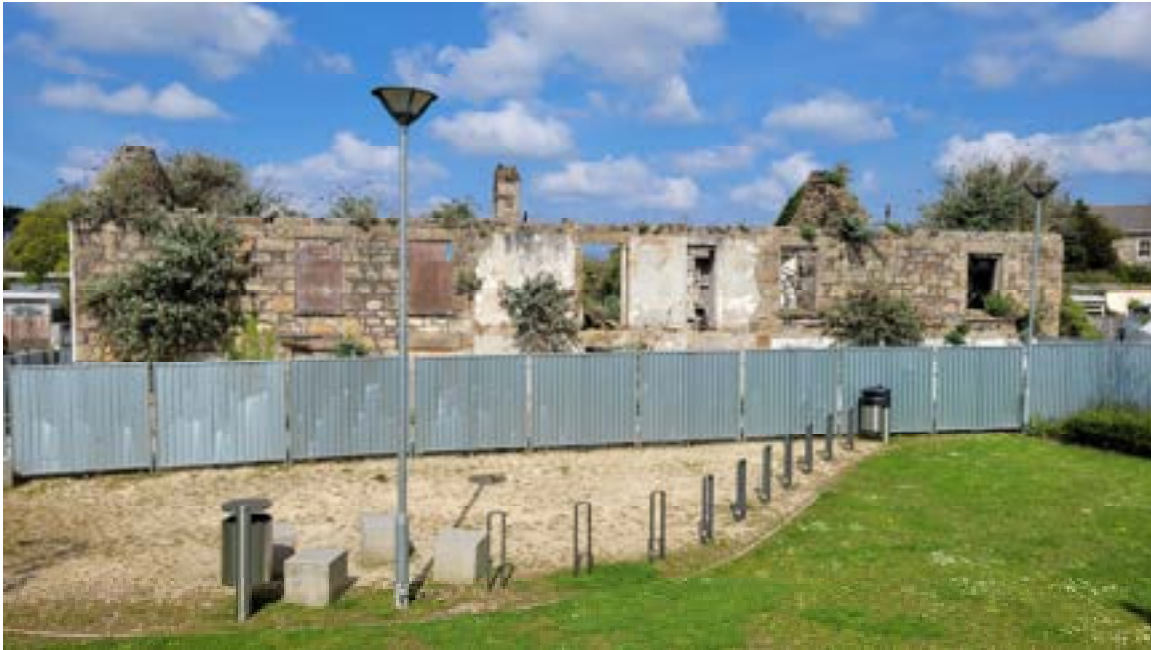
7. East elevation View 1.

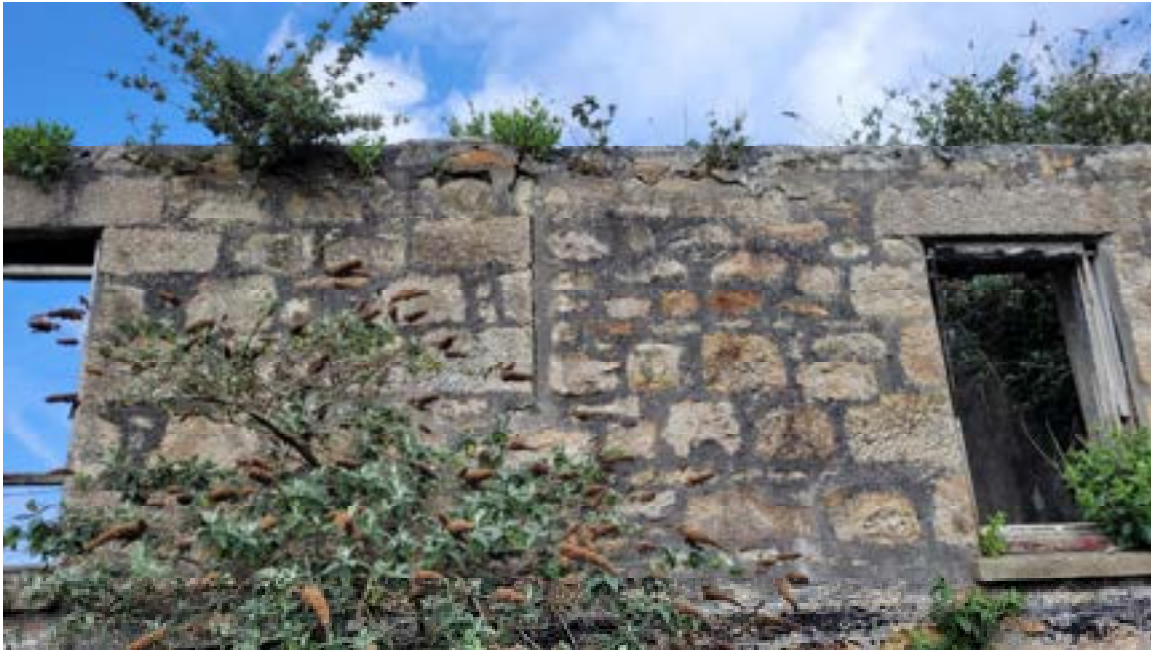
9. Vertical crack and loose stonework to top of wall.

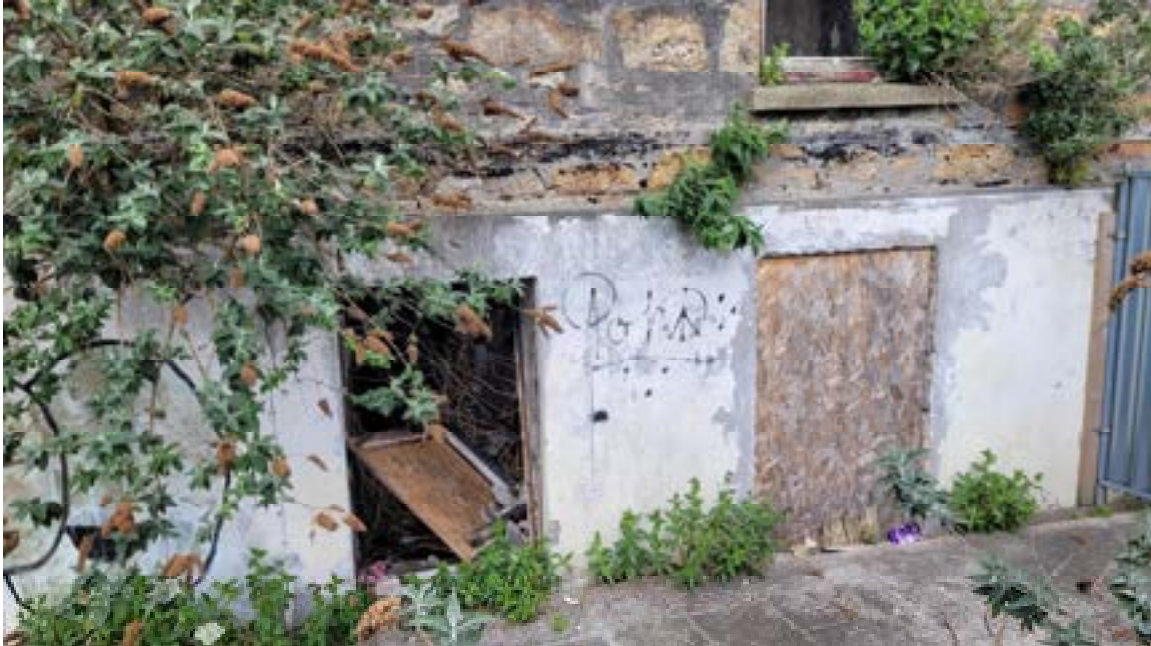
10. Vertical crack extends into render at ground floor level.

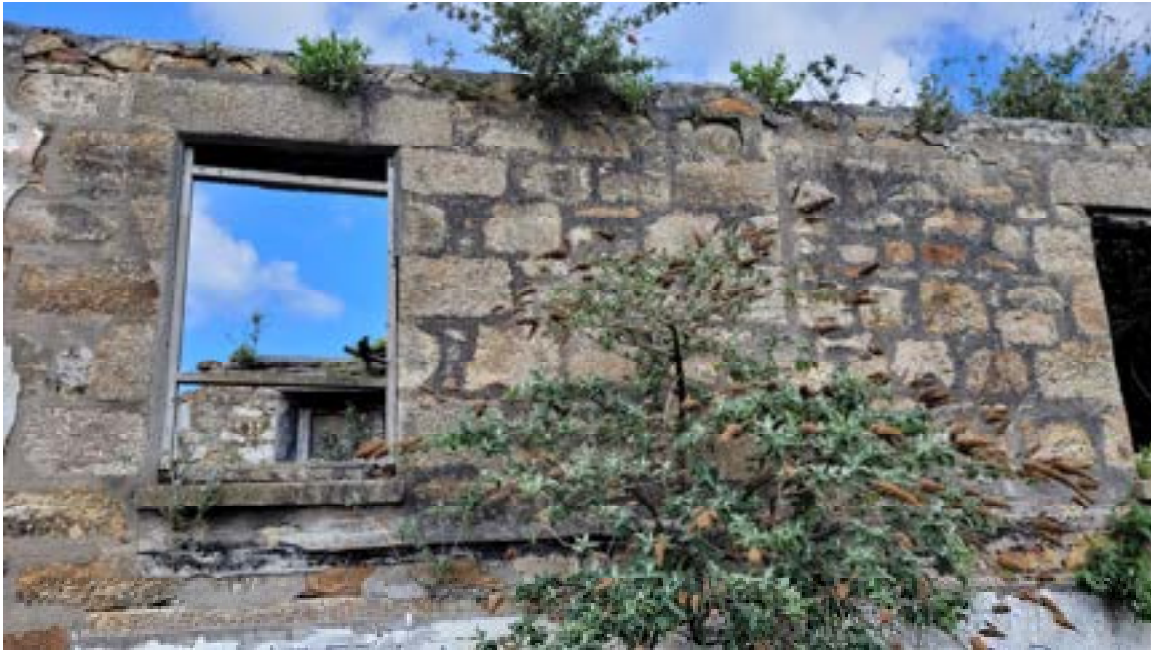
11. Vegetation growing from wall.

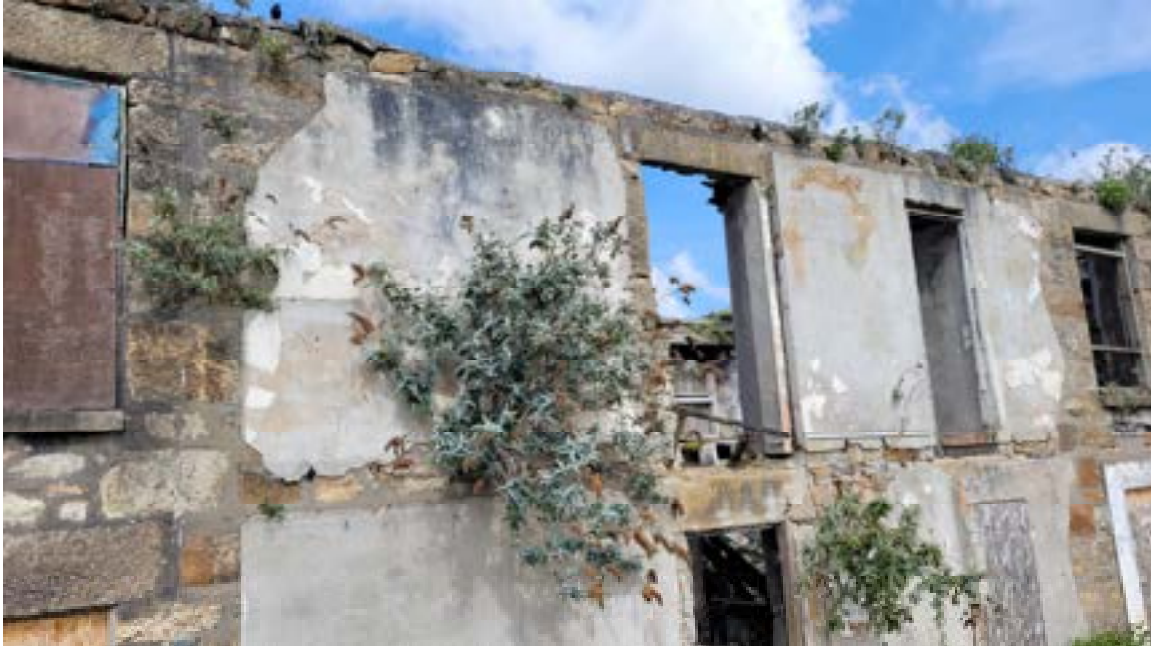
14. Crack to left hand end of first floor lintel. Walling obscured by plaster / render.

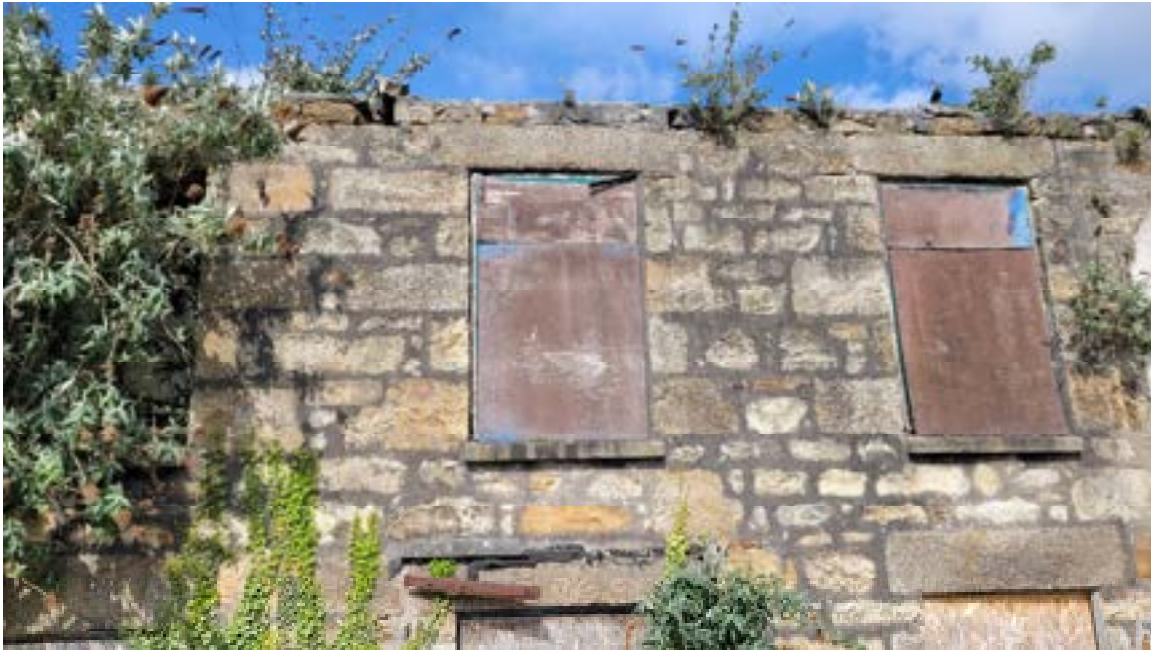
15. Loose stonework to top of wall on east elevation. Embedded metal to left hand end of ground floor lintel.

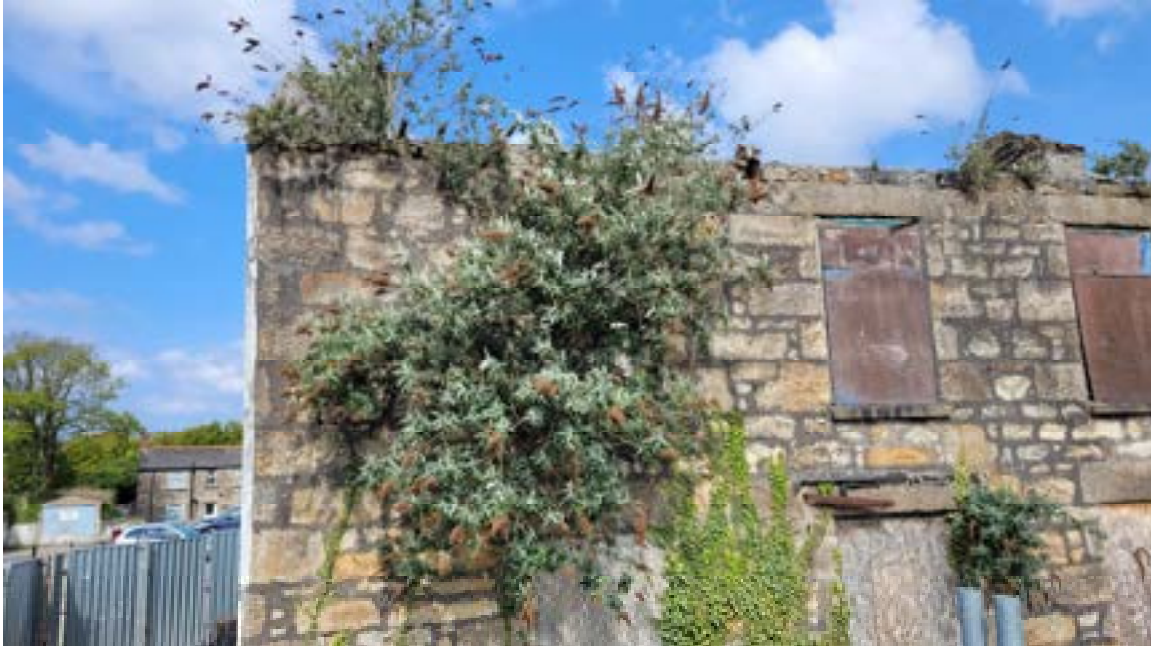
16. Vegetation obscuring window opening on east elevation.

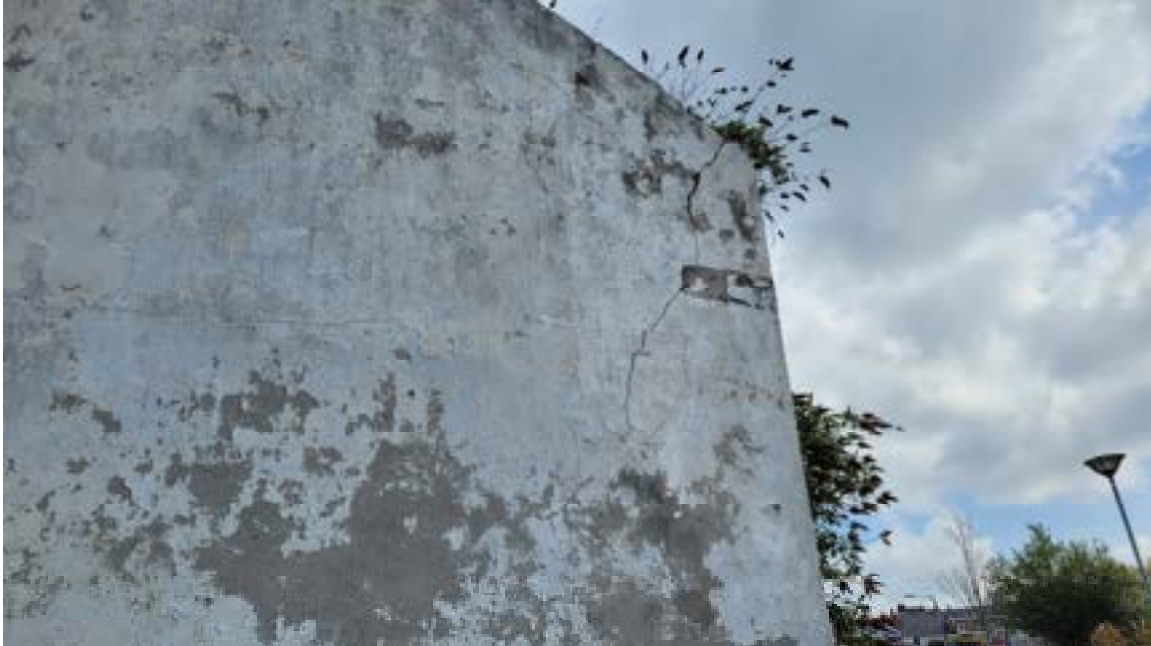
18. Cracking on south elevation adjacent to south east corner.

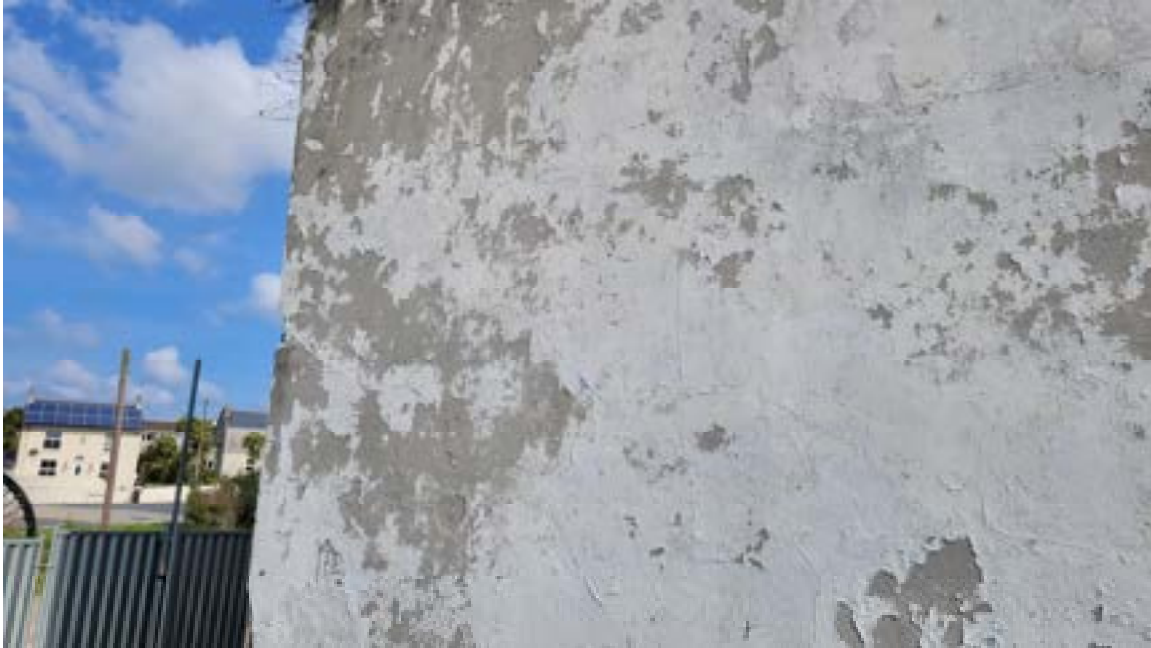
19. Minor crazing to render. Investigation required to determine whether this extends into the stonework beyond.

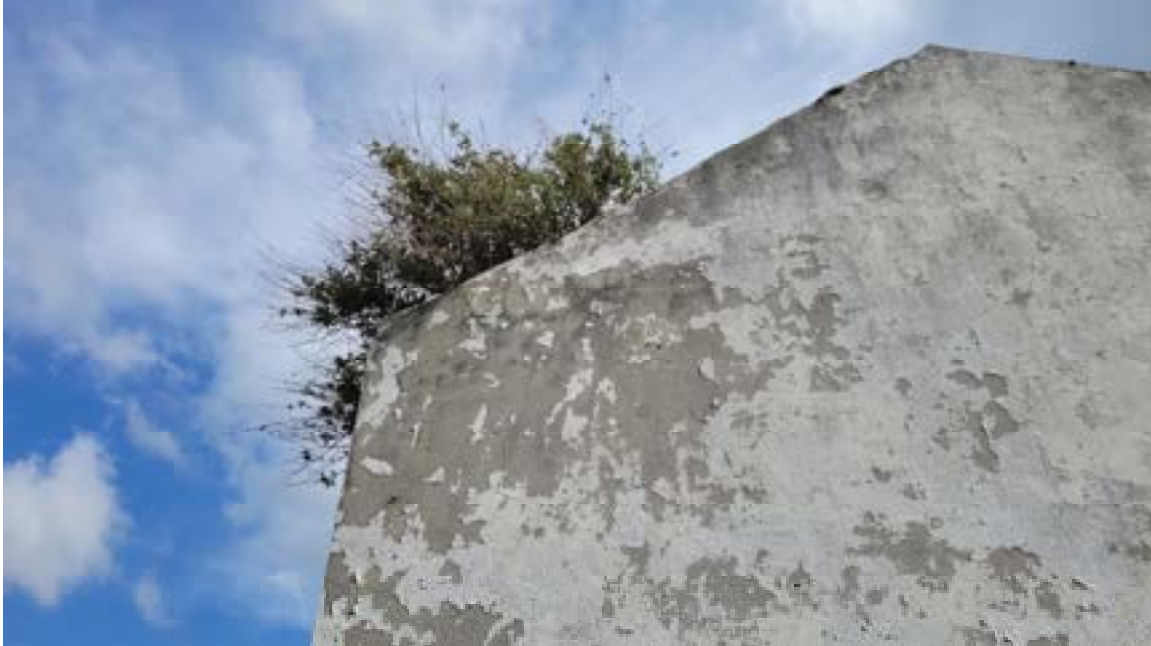
20. Cracking to top of wall adjacent to the south west corner of building.

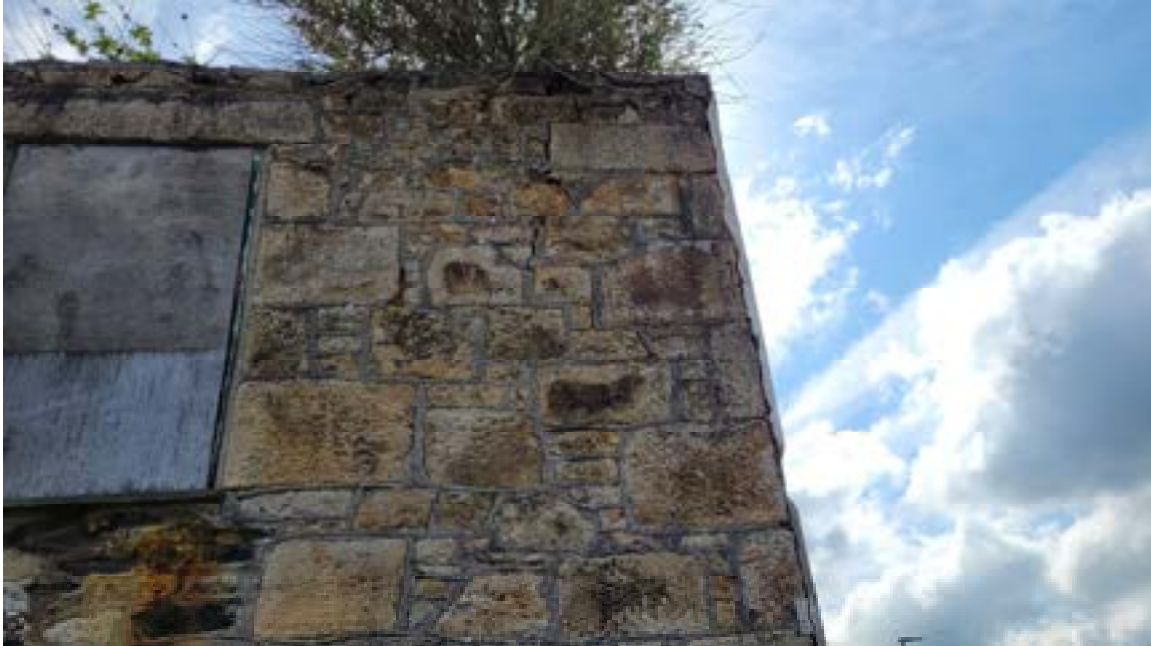
22. Cracking on west elevation adjacent to the south west corner. Note gapping between render on south elevation and wall.

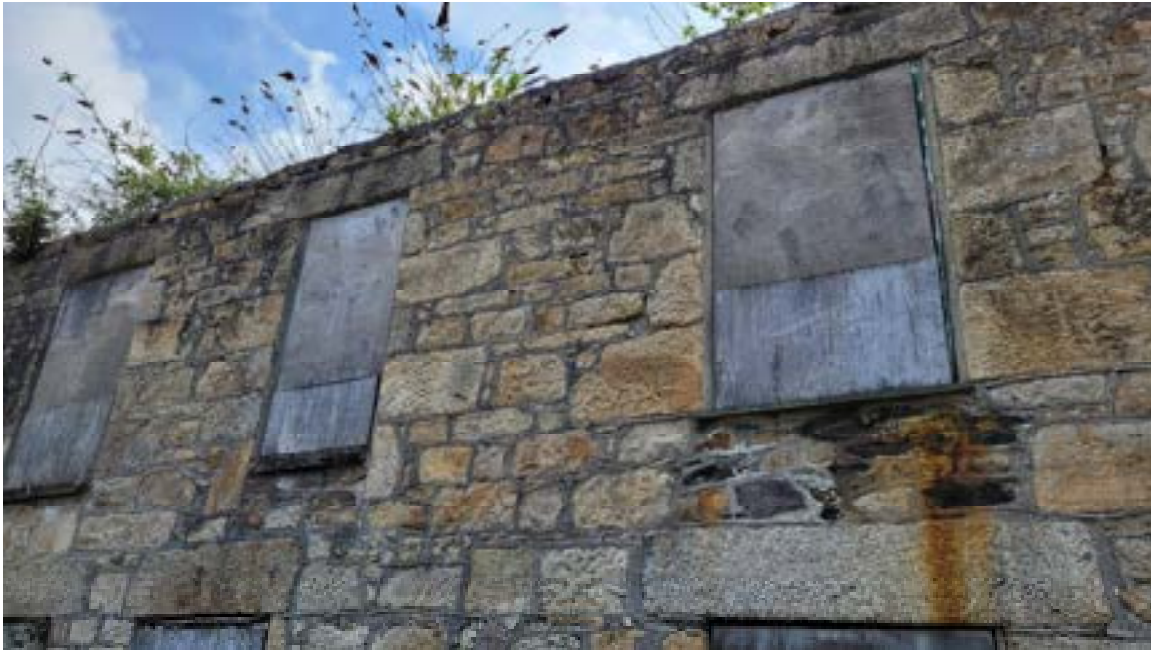
23. Cracking to left hand end of lintel over ground floor doorway and staining on stonework between the first floor and ground floor openings.

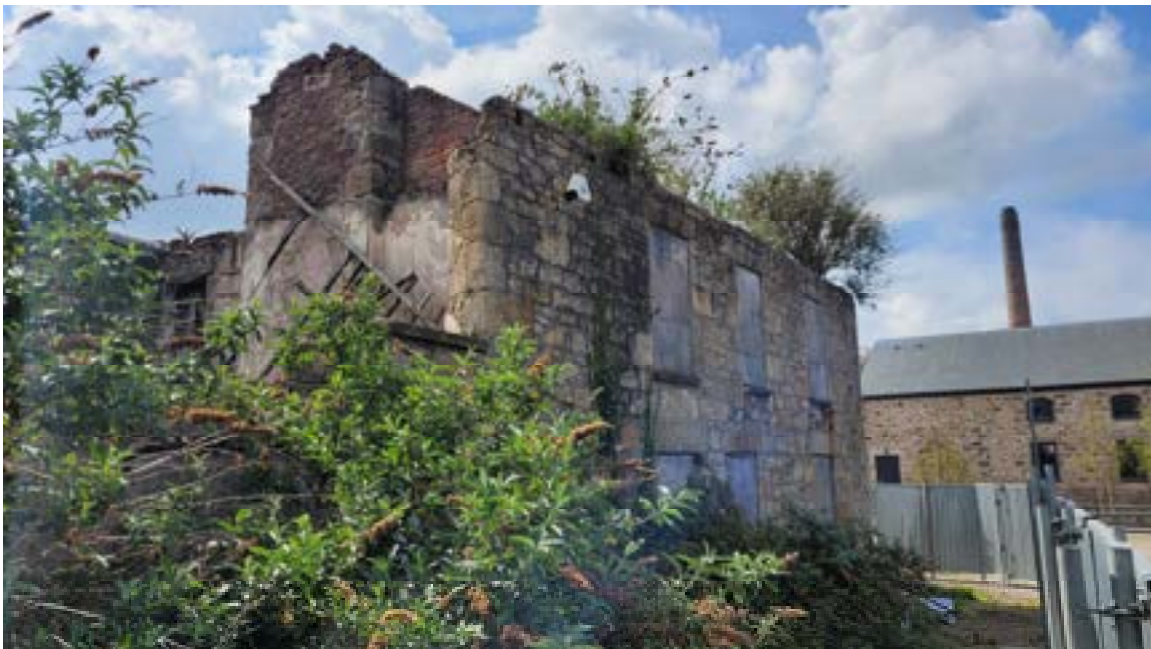
24. Southern end of west elevation.

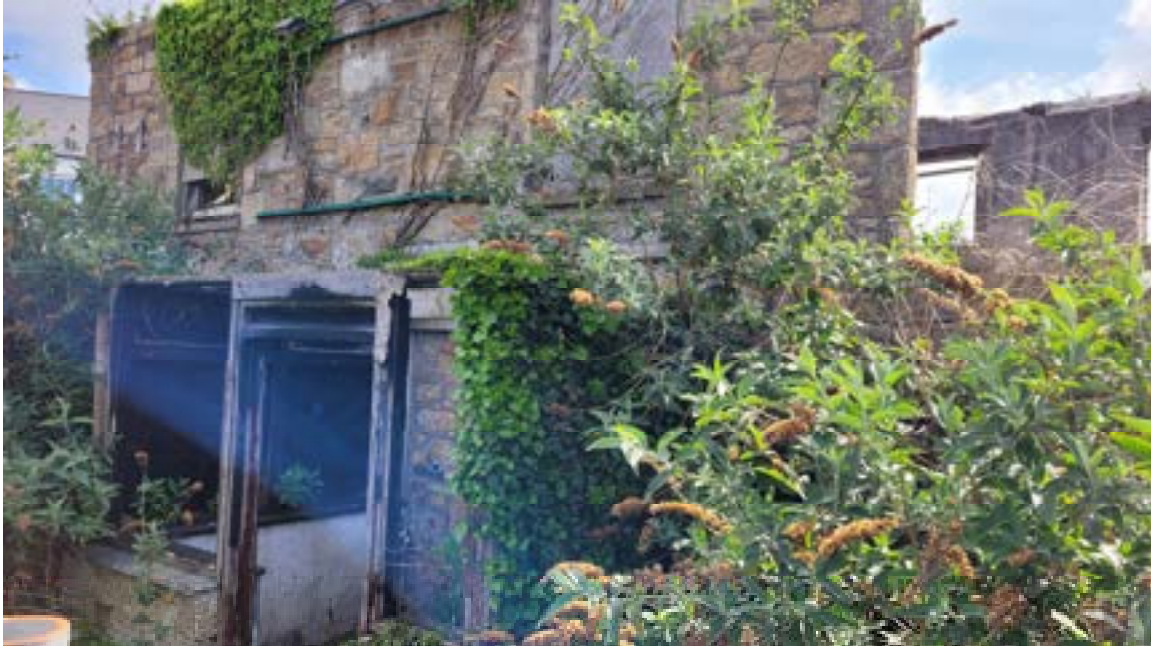
26. Fire damaged single storey lean-to with granite plinth.

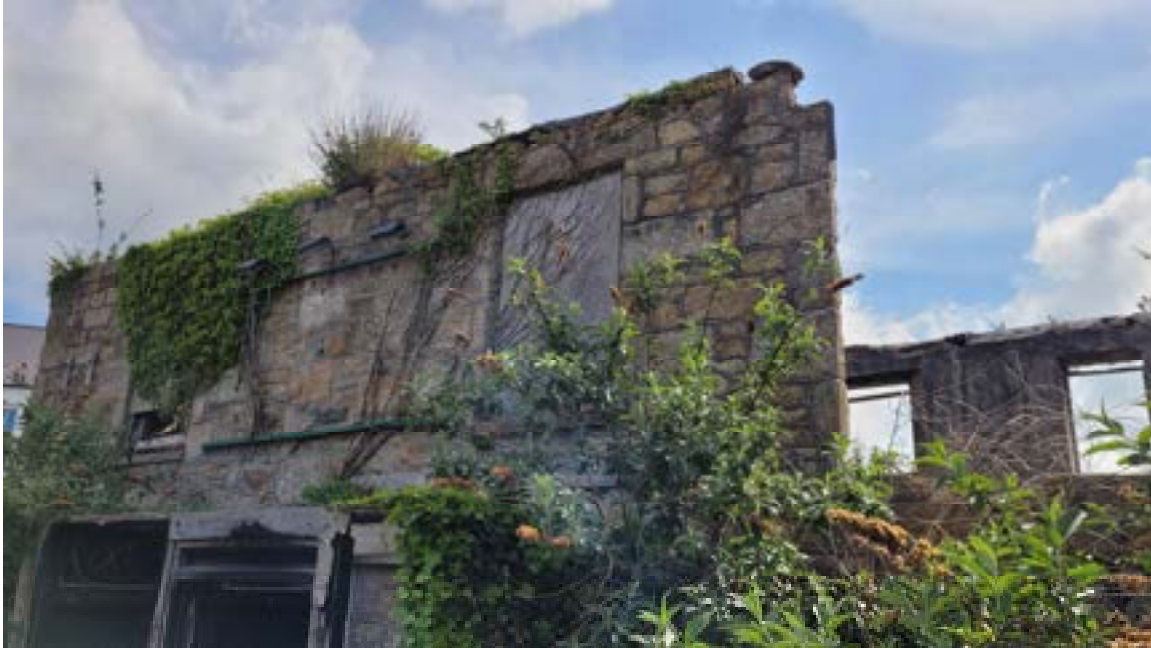
27. Loose stonework at top of the wall and metal angles fixed to the wall. Potential failure and past repair to granite lintel.

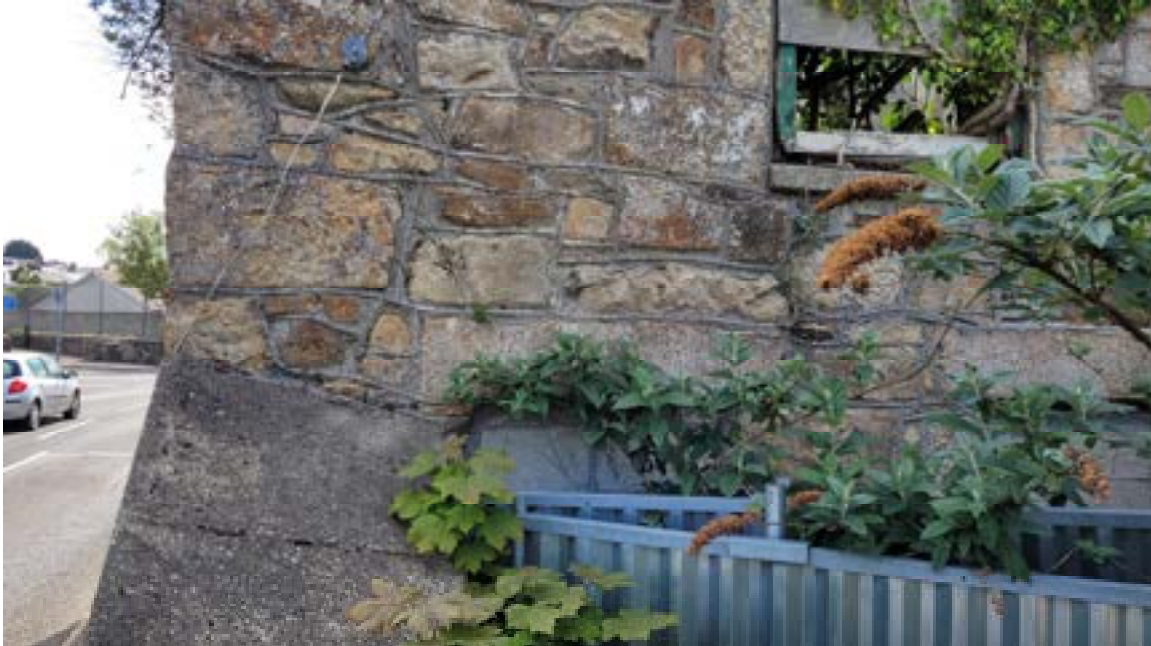
28. Minor cracking in mortar below cill. Ground floor window opening blocked up towards bottom of frame.

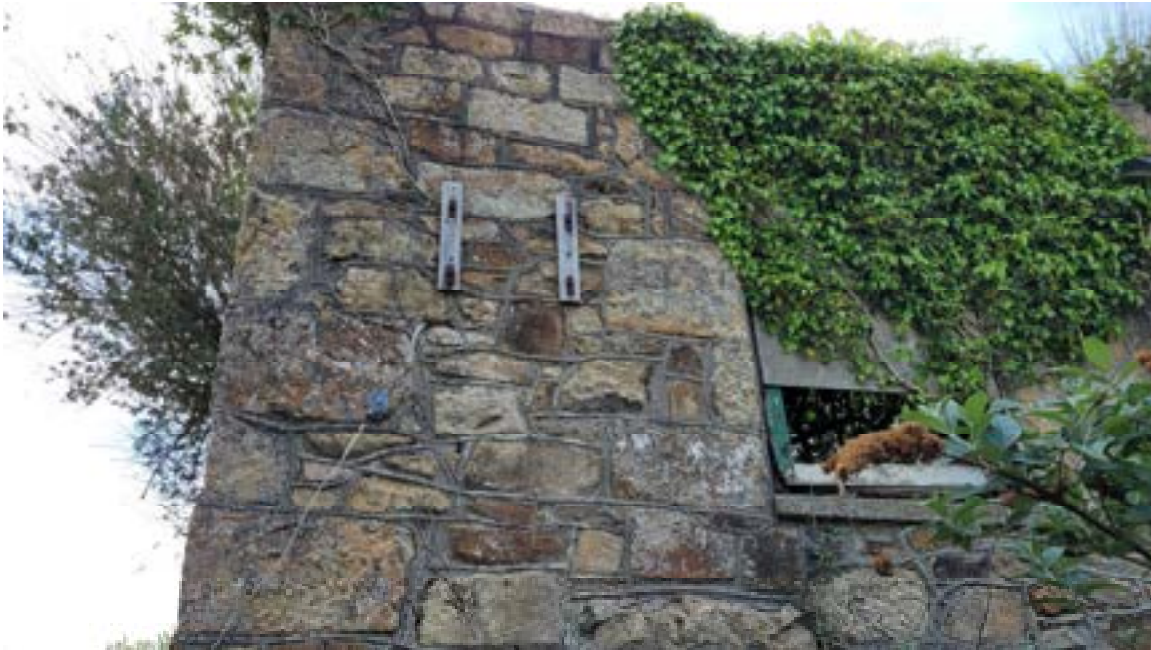
29. Timber and metal fixings secured to wall. Window opening partially obscured by vegetation to right hand side of frame.

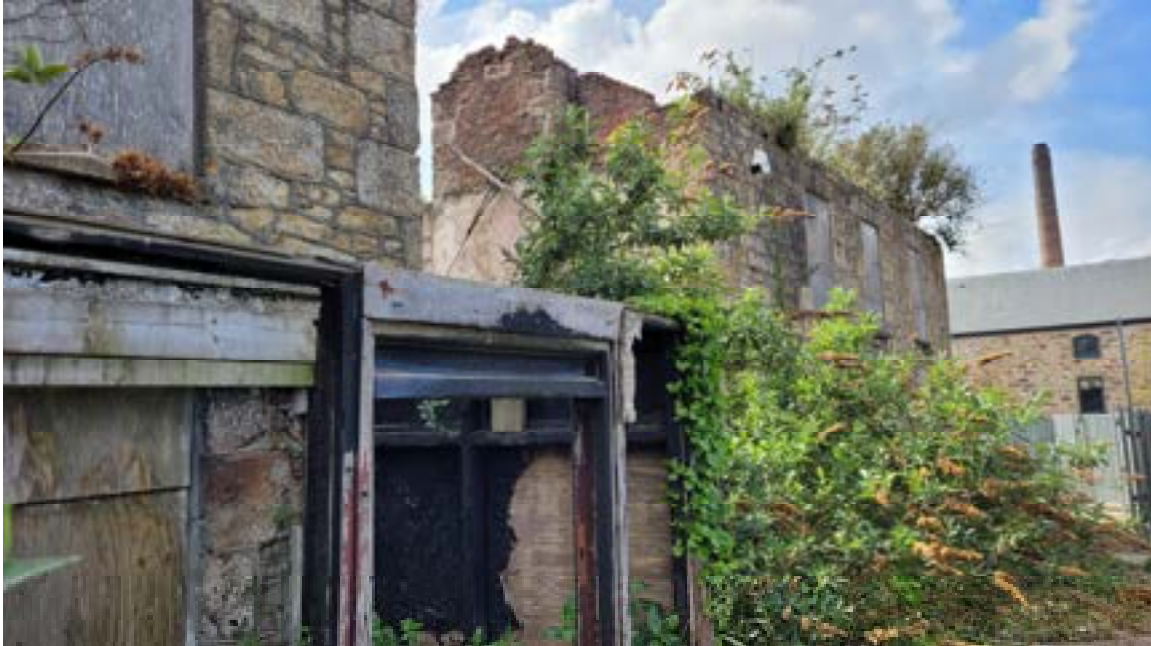
30. View on chimney showing brick panel and loose stonework to top of chimney.

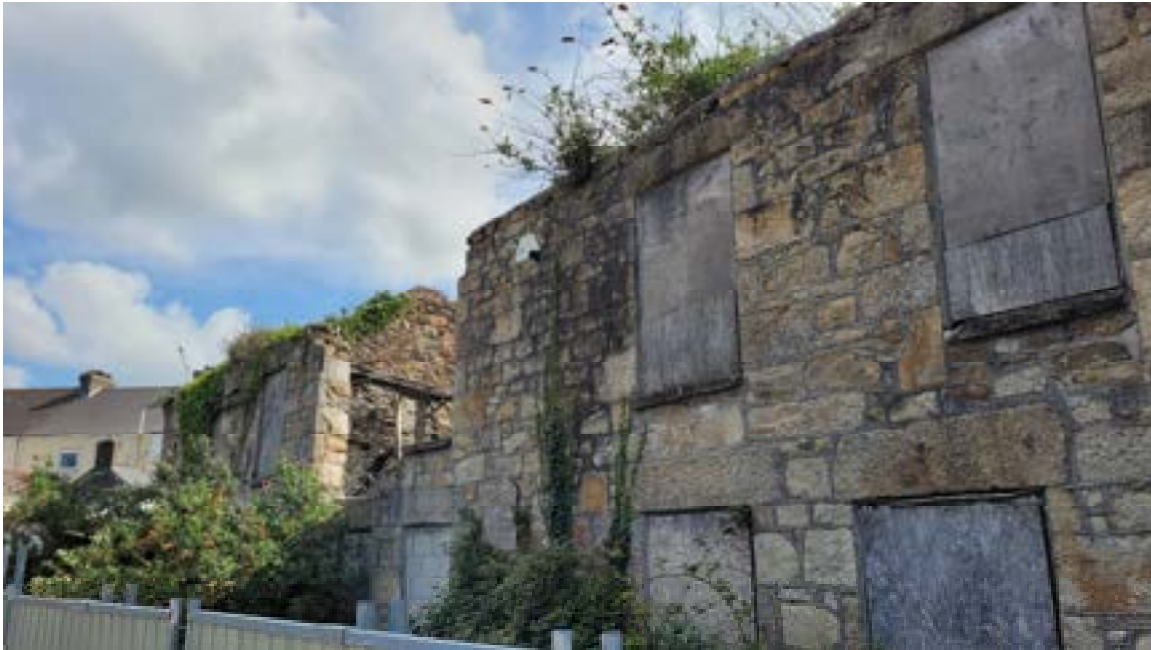
31. View of internal gable towards north end of building showing brick top to gable.

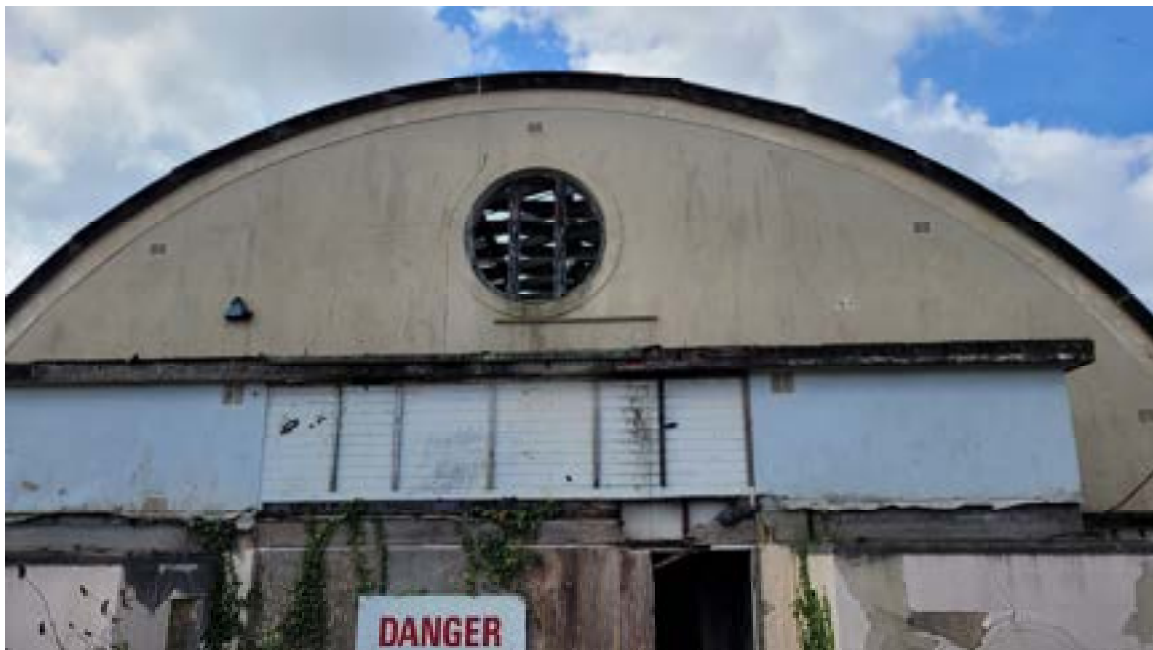
4. View on circular window opening showing vertical crack below. Note concrete roof slab below.

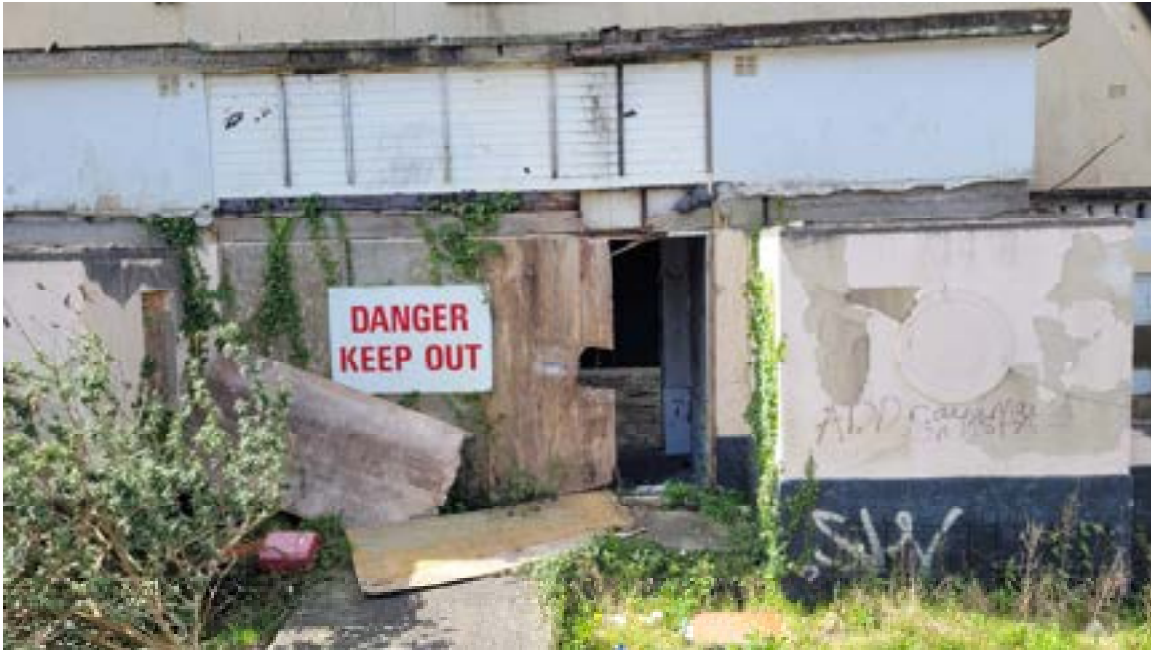
5. False timber panel above entrance with significant decay. Lintel not visible.

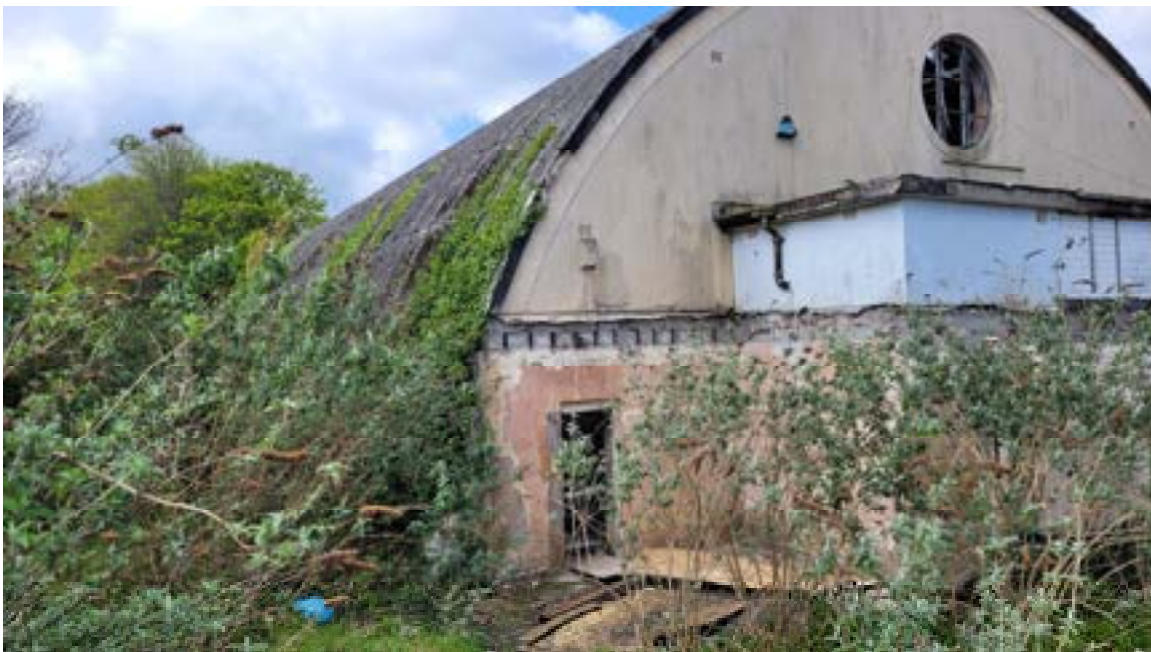
6. Evidence of joists previously built into wall and diagonal becoming vertical crack to left hand side of flat roof slab.

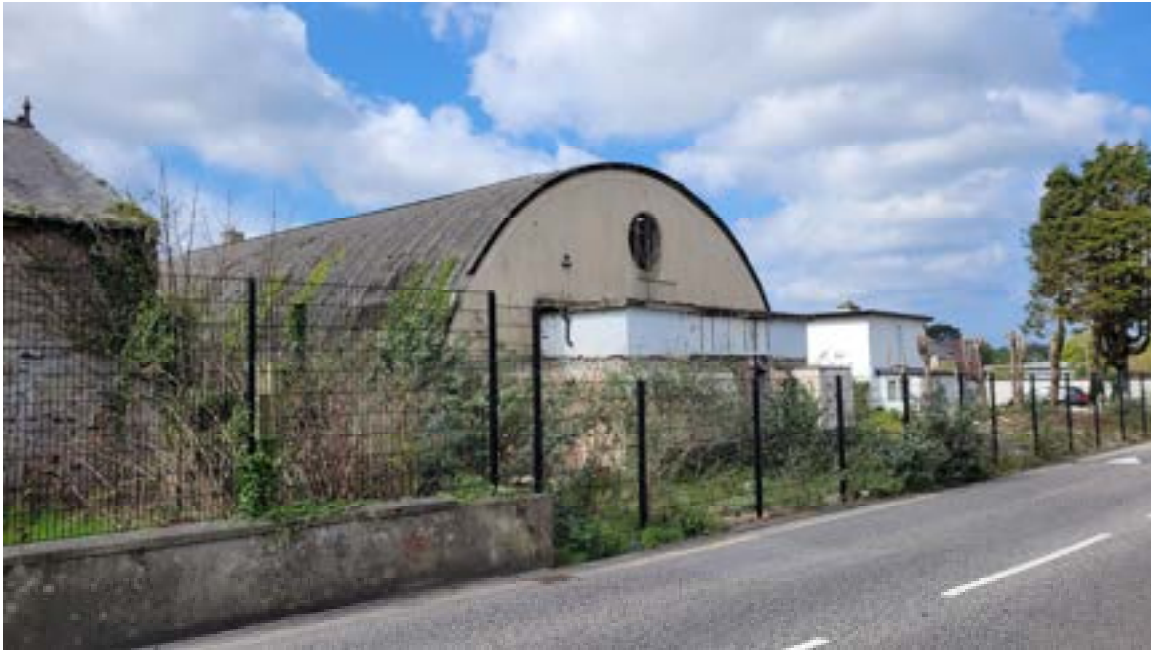
7. East elevation obscured by vegetation.

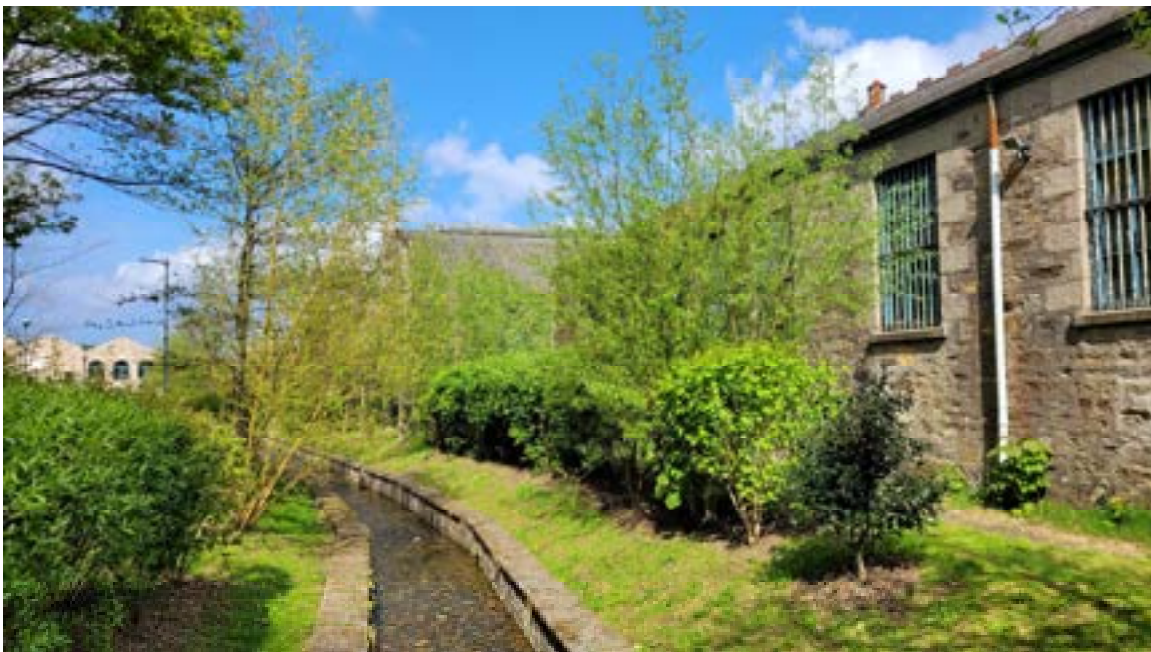
8. East elevation in background showing damage to roof lights to top of barrel vault roof.

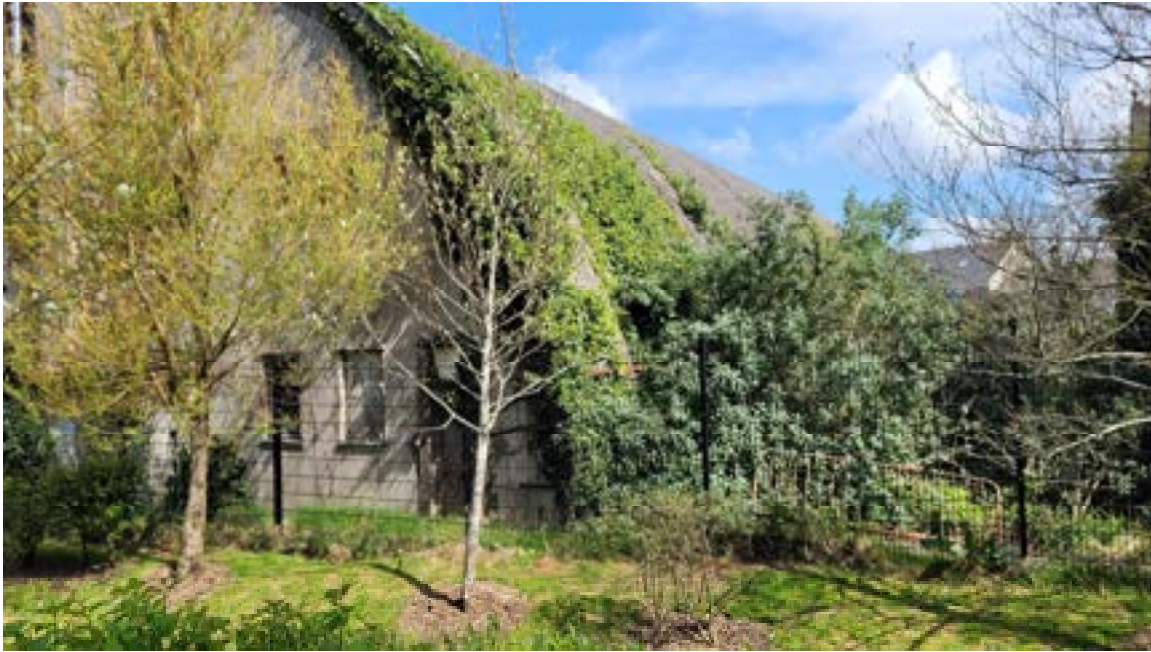
9. East elevation – significant vegetation restricted visual inspection.

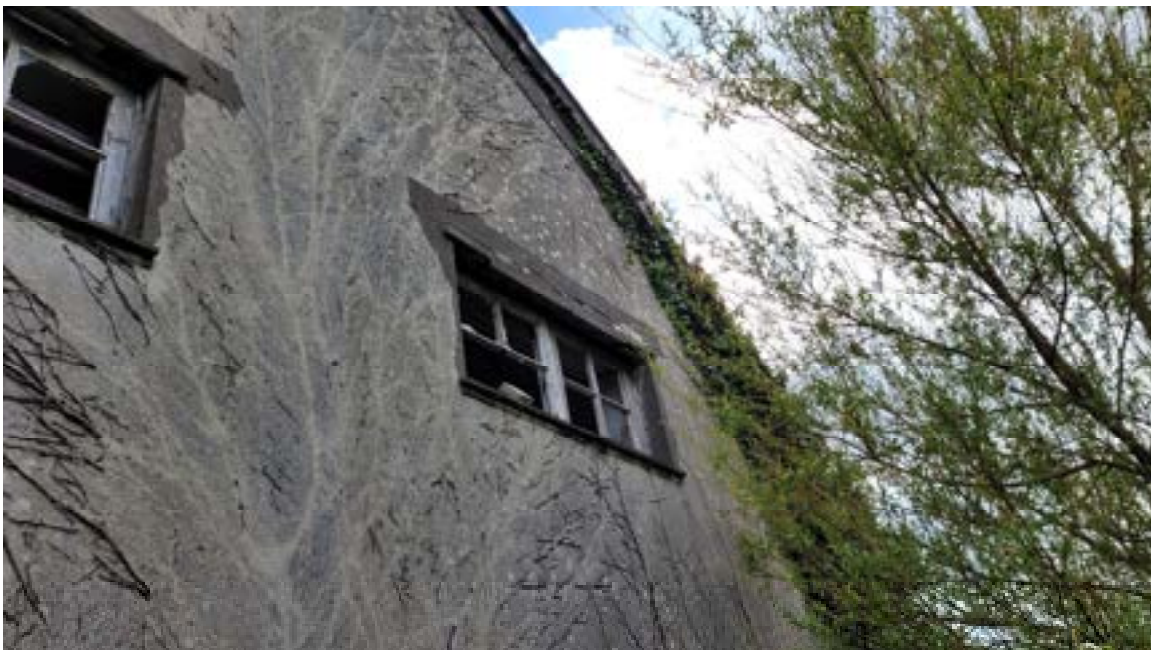
12. Failed lintel due to corrosion.

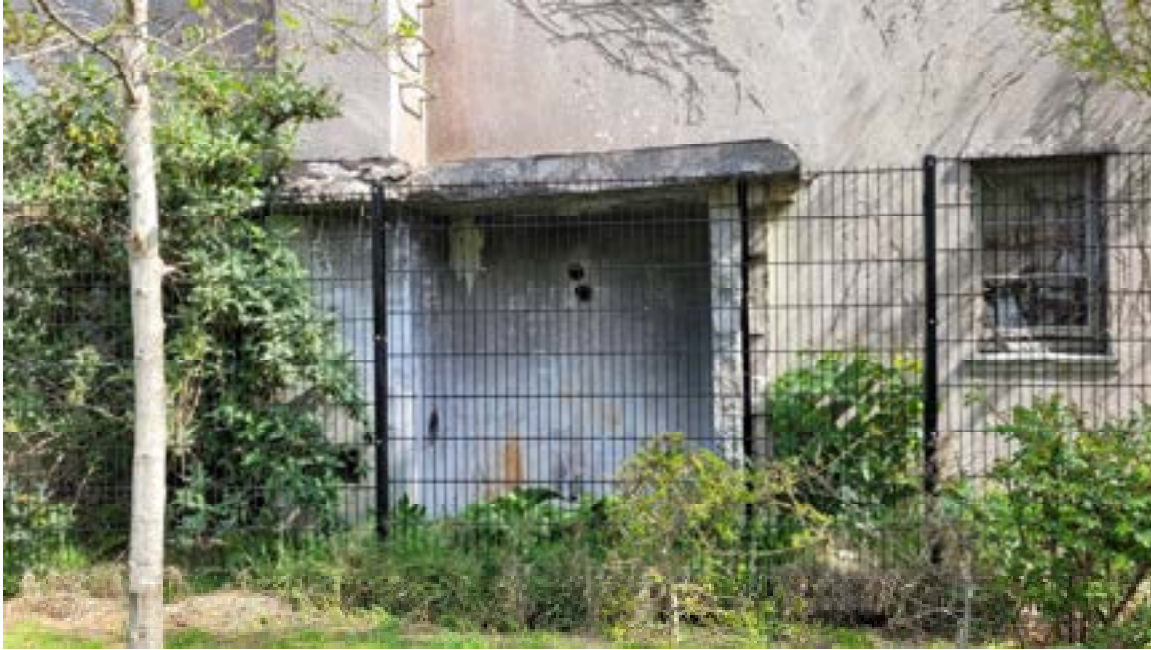
13. Concrete roof slab adjacent to chimney.
