## VISUAL APPRAISAL SURVEY

CHYMBLA HOUSE AND WINKLOW HOUSE,  
FORMER REDRUTH BREWERY SITE,  
REDRUTH,  
CORNWALL, UK

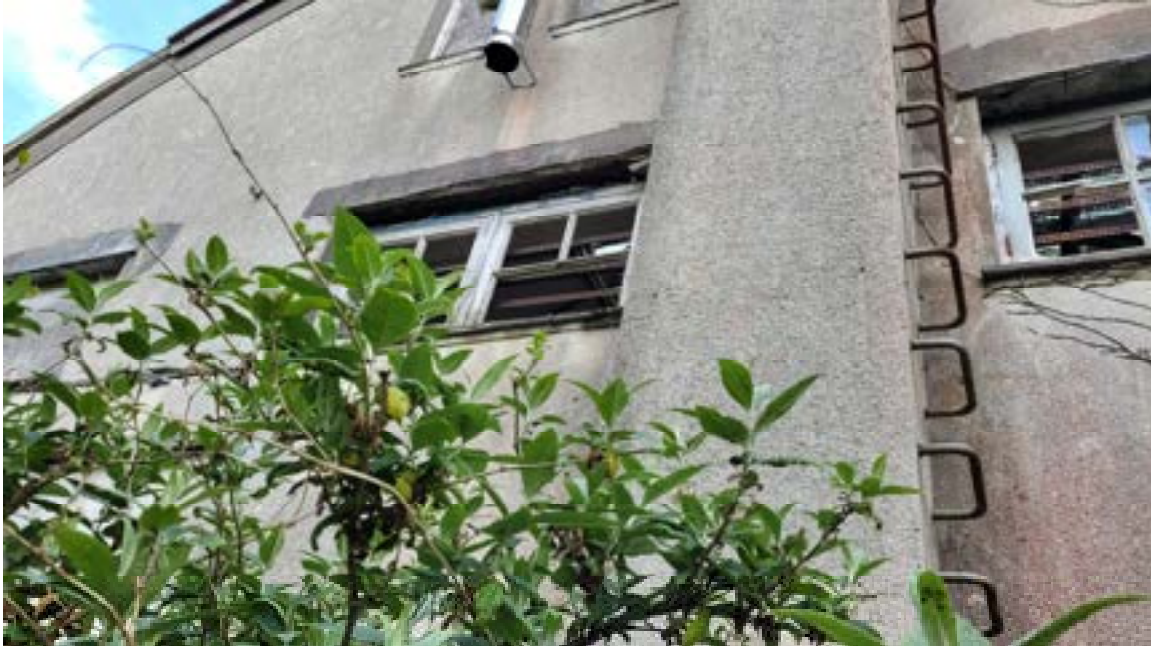
14. Corrosion to lintel soffit on middle band of window openings.

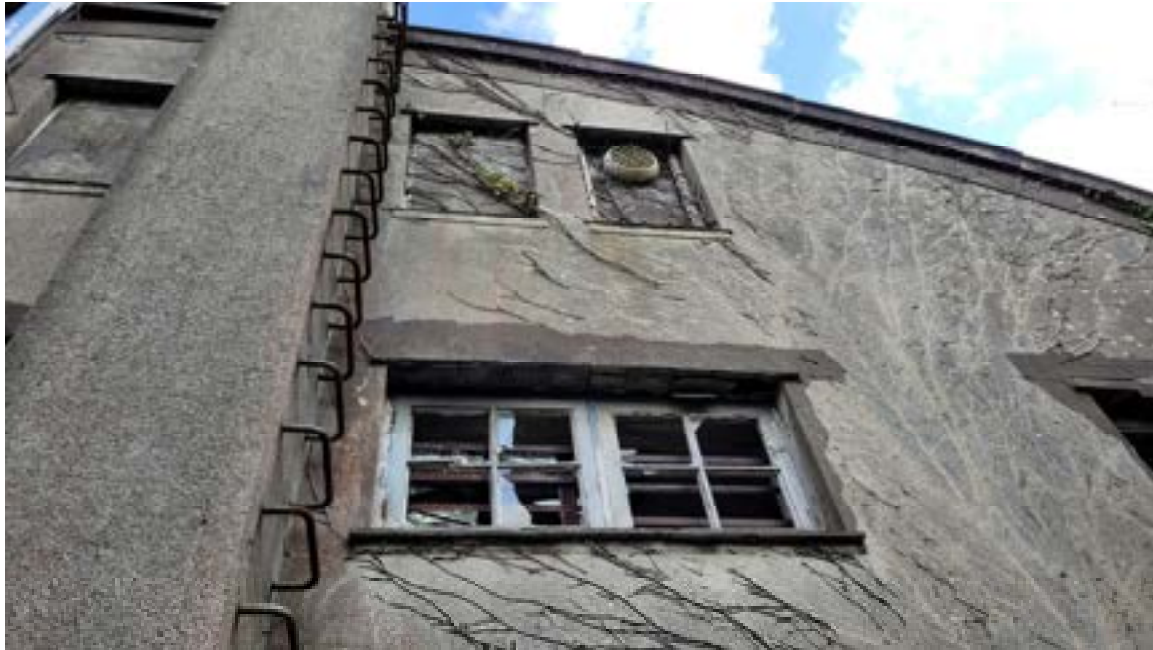
15. Metal ladder rungs embedded into chimney.

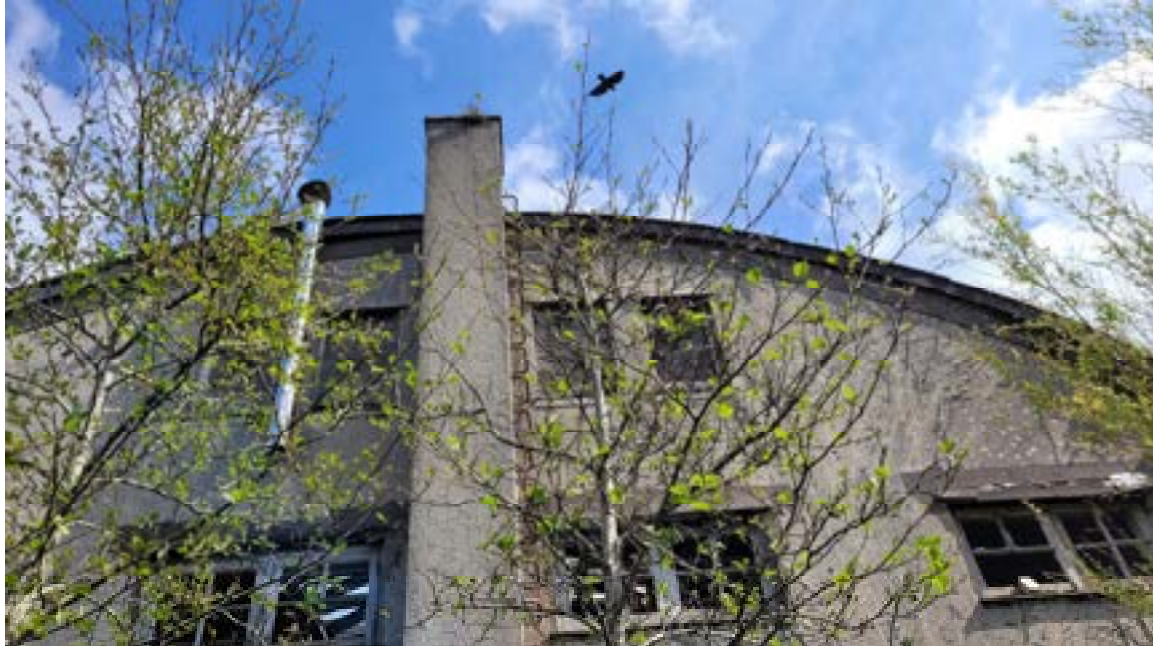
16. Vertical crack to top of chimney below vegetation.

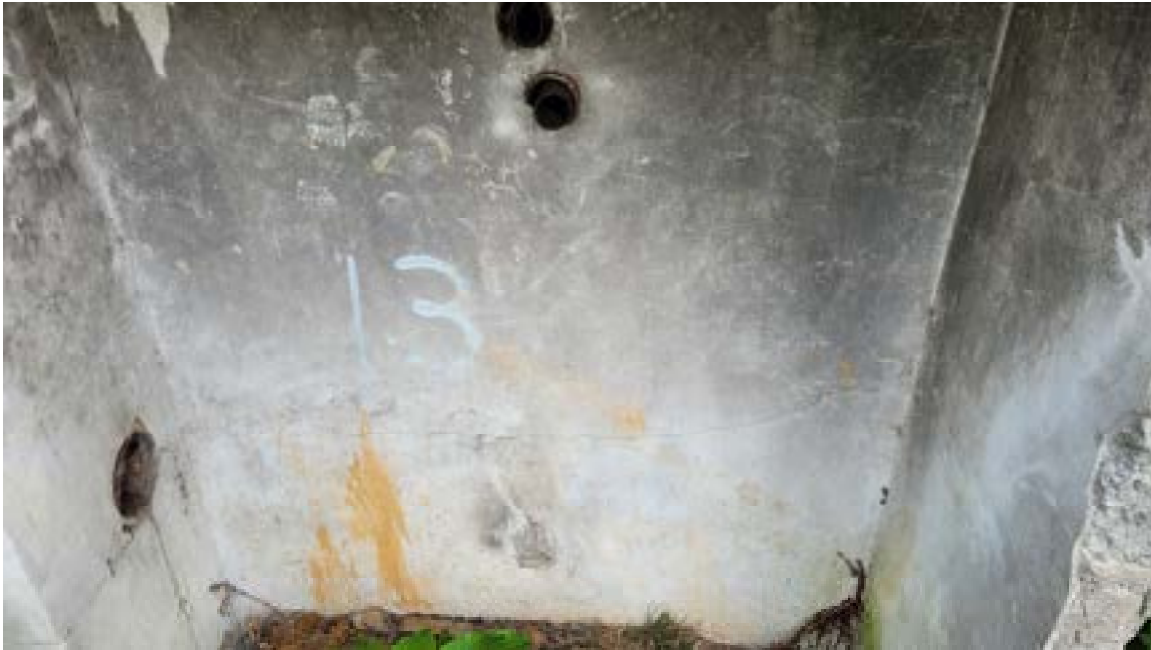
17. Minor horizontal cracking to render to right hand side of chimney on south elevation.

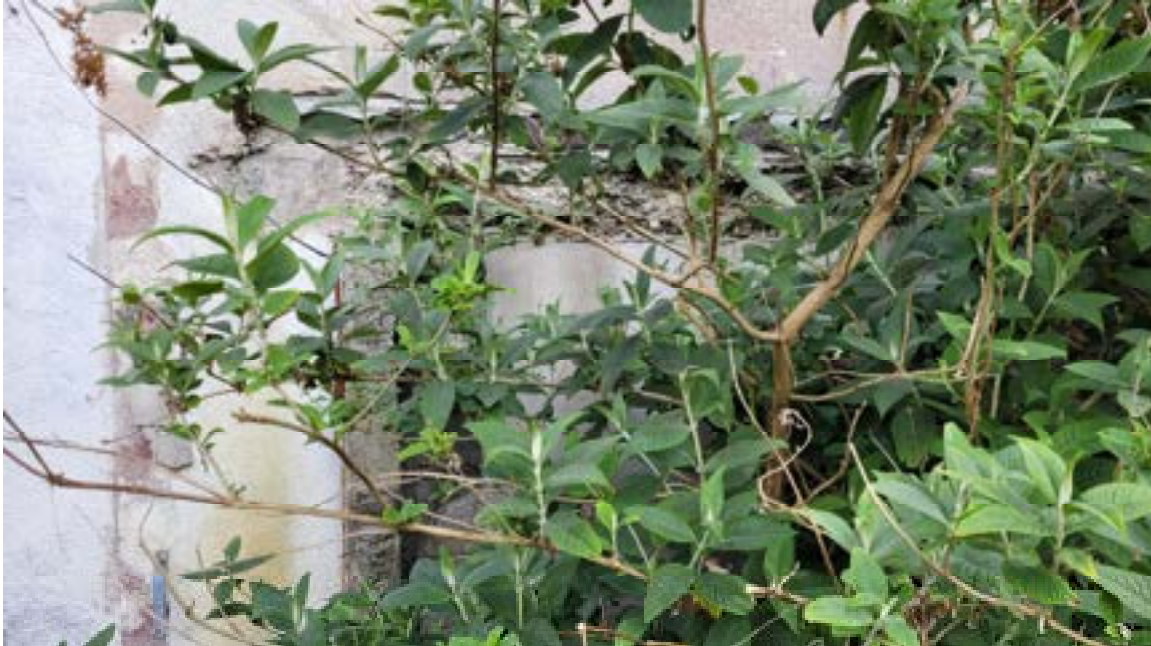
18. Concrete slab cut back to face of elevation. Possibly during demolition of the other buildings on the site.

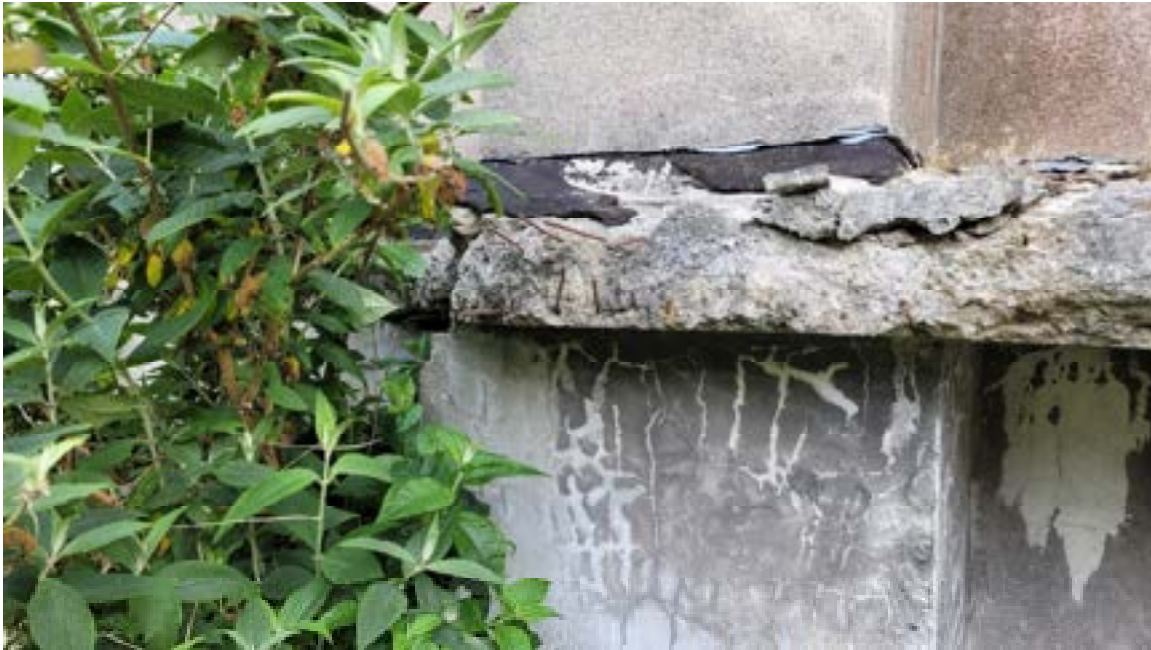
19. Degradation of concrete slab adjacent to chimney.

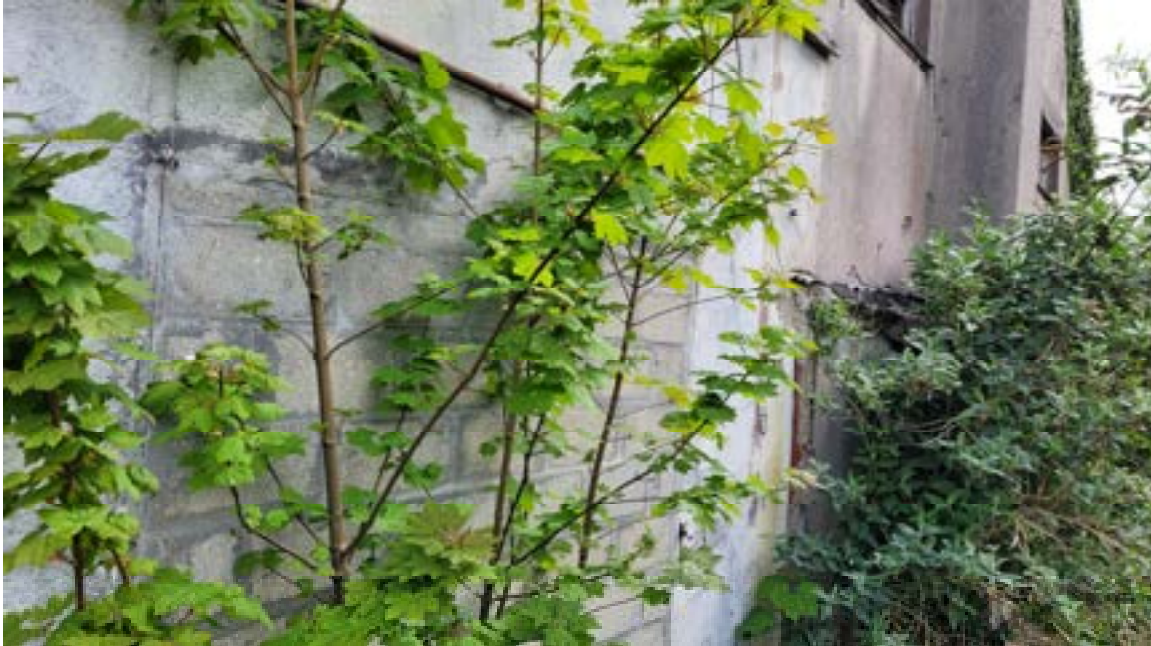
20. Opening infilled with blockwork at ground floor level on the south elevation.  
Note minor horizontal crack to left hand side at lintel bearing.

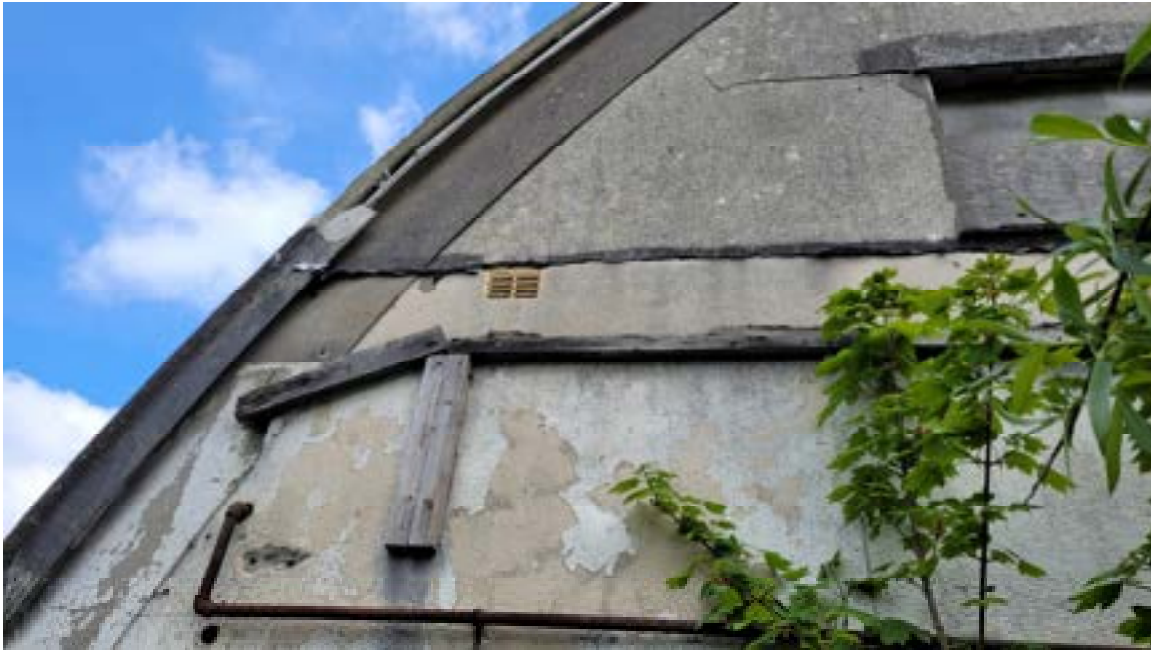
21. Degradation of roof sheeting on verge. Horizontal crack propagating from lintel bearing becoming vertical. Timber and metal pipework fixed to wall. Note chase in wall above these.

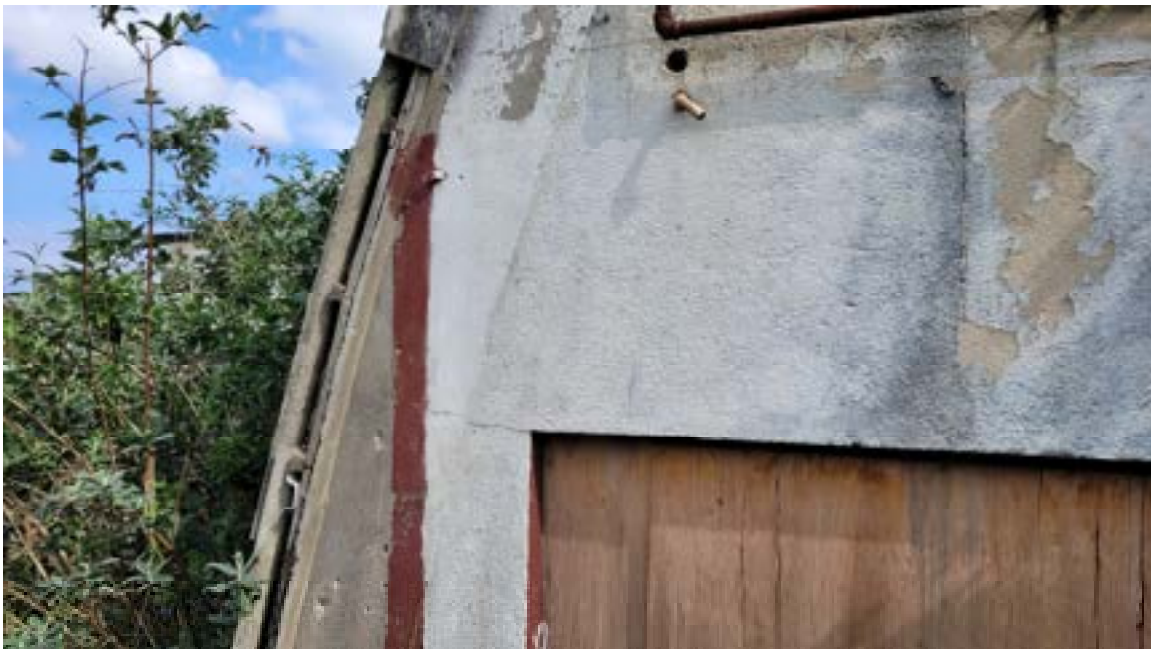
22. Minor horizontal crack propagating from ground floor opening adjacent lintel to south west corner of building on south elevation.

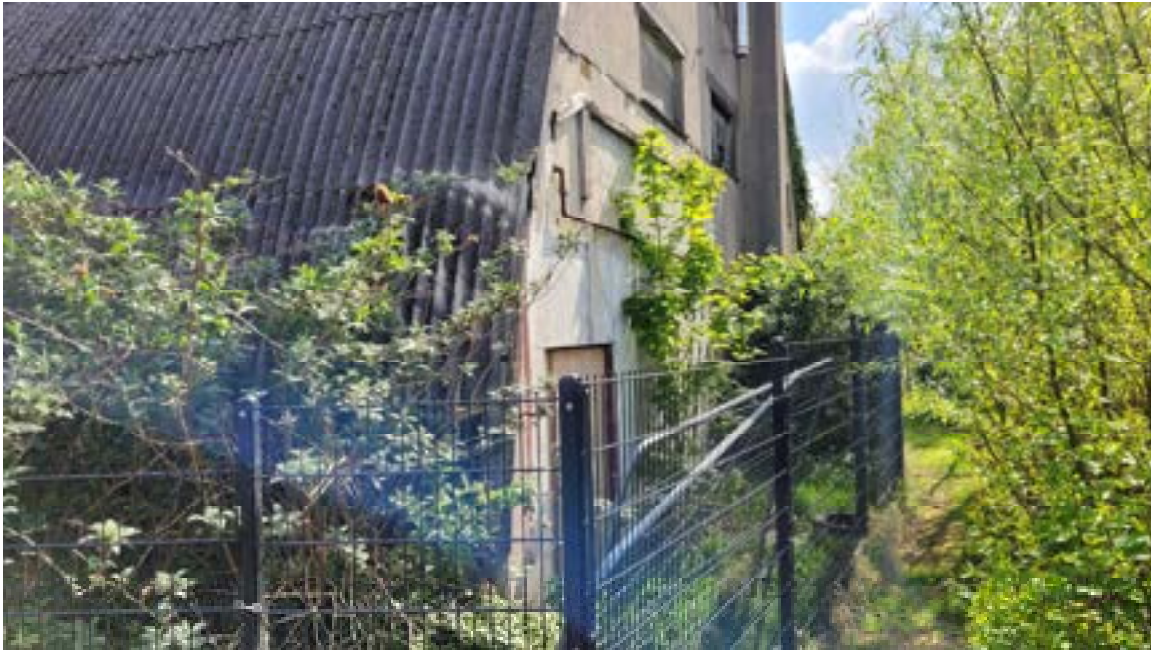
23. Damage to roof sheeting on south west corner of building.

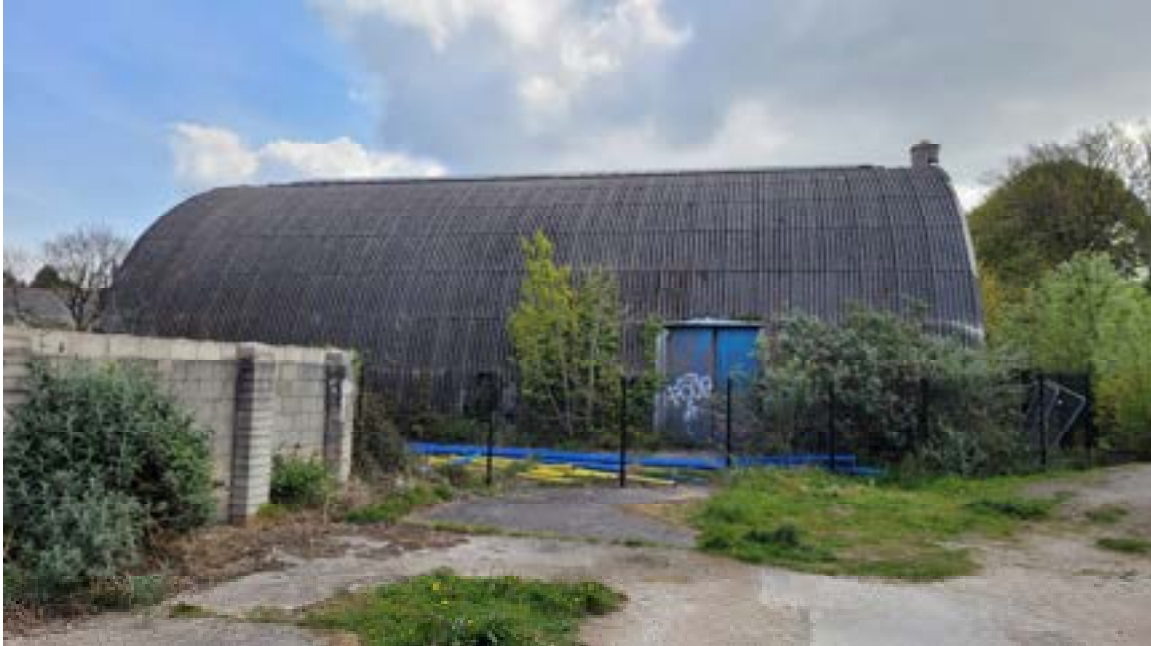
24. West elevation overview.
